Technical Service Bulletin

20 MIL on (DTC P045600 - EVAP System Leak Detected NVLD (very small leak))

20 13 27 2035073/1 October 16, 2013.

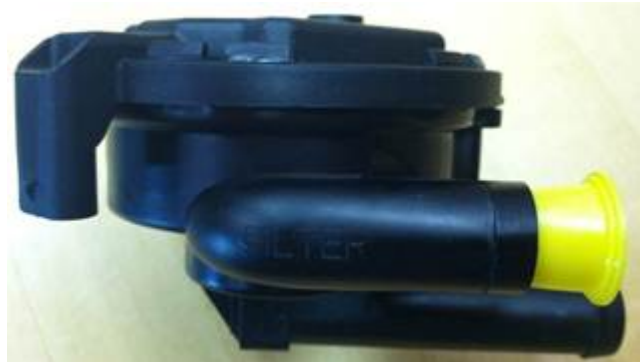
Figure 4. Example of plug inserted *inside* the pressure sensor filter pipe.

- Disconnect the air filter hose from the pressure sensor. Seal the pressure sensor opening with a clean plug from the Engine Bung Set VAS 6122, or similar (Figure 4 and Figure 5). The plug must fit securely and not allow any air to leak.
- Pressurize the EVAP system to 12 inch/water (30mbar), and check pressure loss over time.

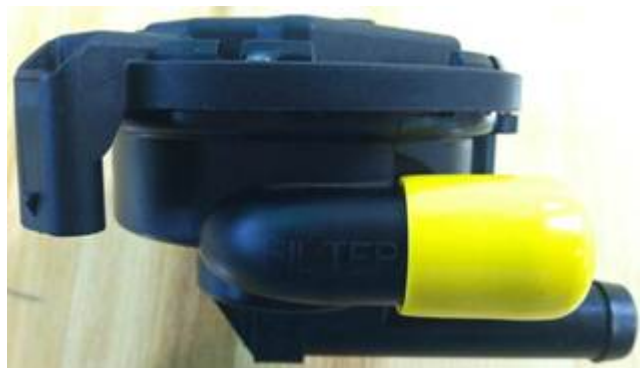
Figure 5. Example of plug inserted *over* the pressure sensor filter pipe
