# Tech Tips

TT 20-12-03

2011-2013 Jetta Sedan Equipped With TDI Engine – Fuel Gauge Does Not Read Full after Fueling

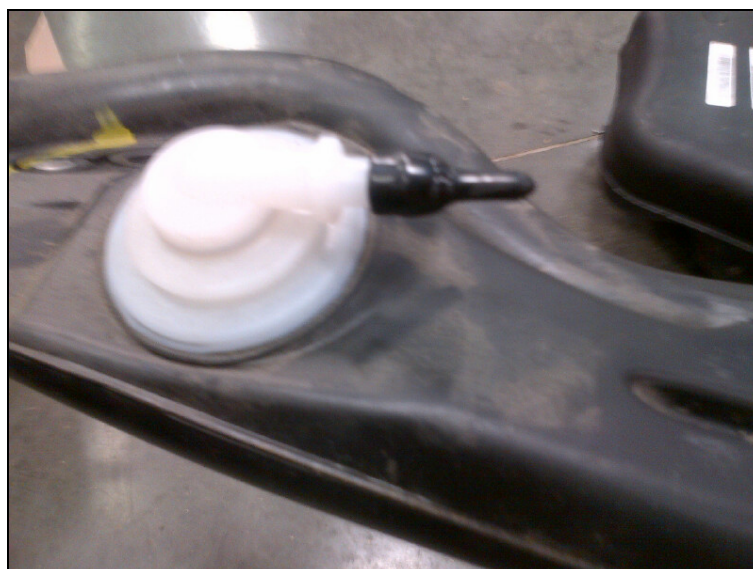
When diagnosing a customer concern of fuel gauge not reading full after fueling, start by checking for the presence of a cover over the fuel tank vent as shown in the picture below. Vent is located on filler neck and can be inspected by removing fuel door assembly. If cover is found over vent, **inspect for damage to fuel tank and replace tank if needed. Ensure cover is not present on replacement fuel tank.** If fuel tank is not damaged, remove cover over fuel tank vent and retest for customer concern. If cover is not present over vent, continue with normal diagnosis.
