Technical Bulletin

01 13 30 September 4, 2013 2034898

MIL ON, DTC P0401 Exhaust Gas Recirculation Flow Insufficient Stored in ECM Fault Memory, Could be Accompanied with Fault P2463 DPF Soot Accumulation

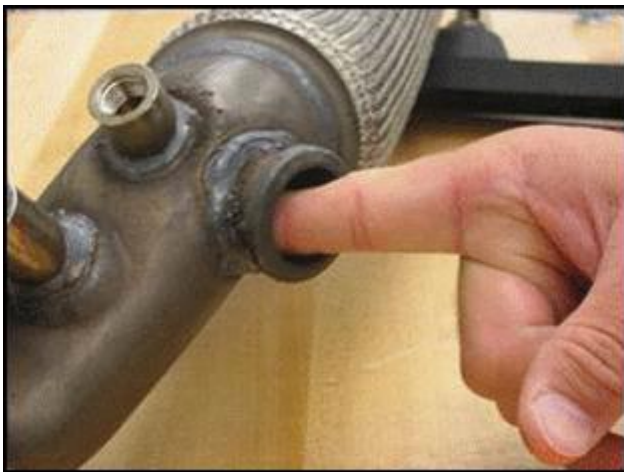
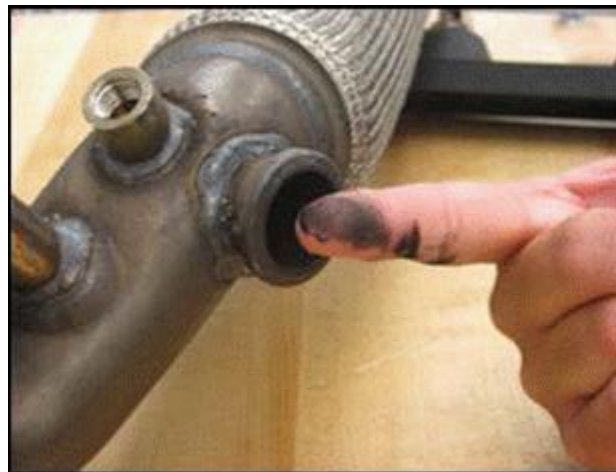
Figure 1

High soot loads prior to regeneration can cause possible restrictions in the EGR filter.

- Remove the EGR filter from the DPF and swipe the inside of the exhaust pipe at the EGR filter connection point using a clean cloth or your finger. See figures 1 and 2 below.

If your finger or the cloth comes out with black soot, replace the DPF & EGR filter together.

If there is no soot on your finger or the cloth, continue with GFF diagnostics, this bulletin does not apply.

When replacing the DPF for the fault P0401 it is important to replace both the DPF and the EGR filter together, as soot accumulation in the EGR filter is undesired. It is NOT necessary to replace any other components for this fault (i.e. NOx Storage Catalyst, Sulfur Catalyst, Exhaust Flap, EGR Cooler), these components should be reinstalled in the vehicle with the new DPF and EGR filter.

After installing the new DPF and EGR filter, ensure that the ECM has been programmed to the latest version. The updating of the ECM should be charged to the appropriate RVU or Technical Bulletin.
