# Recall Bulletin

## PRODUCT SAFETY RECALL

**SUBJECT:** Loss of Battery Charge – Replace Generator Control Module

**MODELS:** 2012-2013 Buick LaCrosse, Regal  
2013 Chevrolet Malibu Eco  
Equipped with eAssist

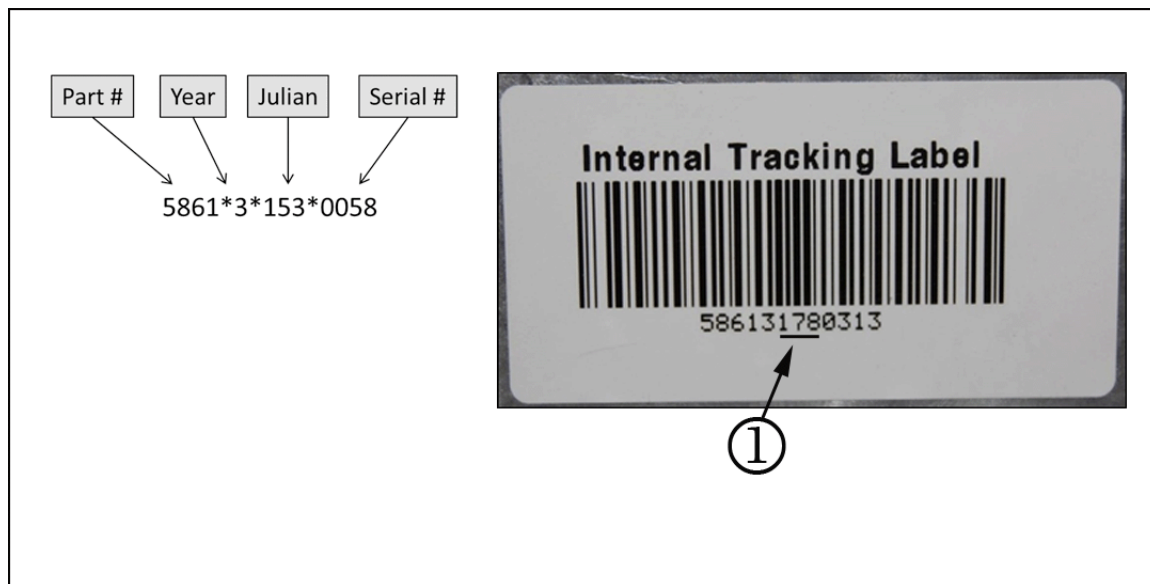
3600552

Generator Control Modules (GCM) with part number 24269448 or 24266403 require an inspection prior to installation in a vehicle. GCMs with part number 24267940 or 24267941 do NOT require inspection prior to installation in a vehicle.

Do NOT provide technicians with GCMs (p/n 24269448 or 24266403) that have a Julian date of 171 through 199. Determine the Julian date following the steps below. Return modules that fail the inspection according to Special Return Bulletin #G\_0000171850.

1. Locate the barcode label on the new GCM.

2. Determine the Julian date (1) as shown above.

- If the Julian date (1) is 171 through 199, do NOT install the module. Obtain another module and perform the inspection again.
- If the Julian date (1) is NOT 171 through 199, provide to the technician for installation in the vehicle.

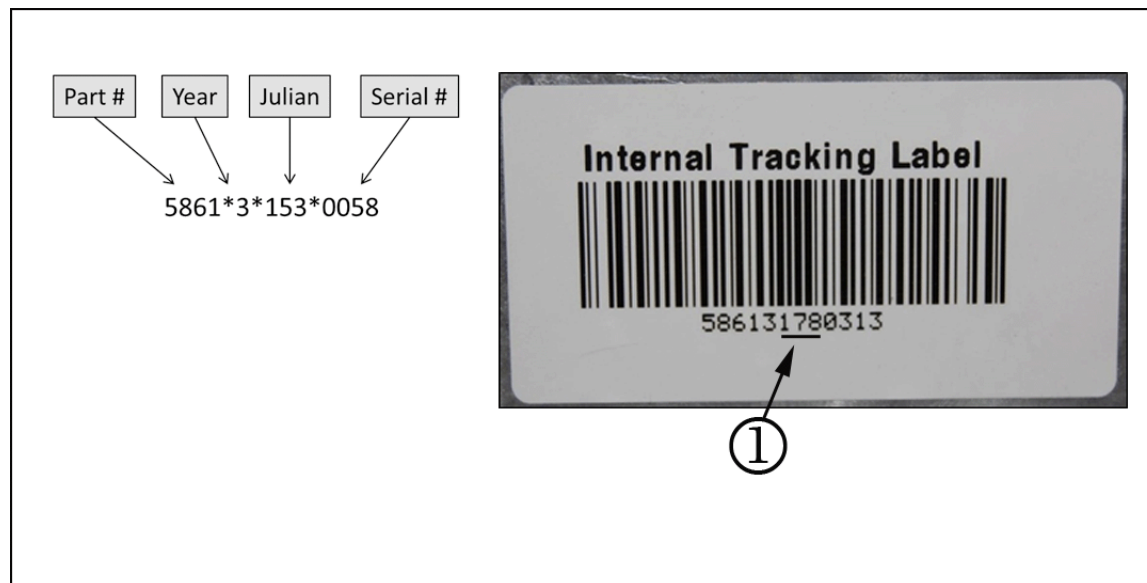
**Note:** Do NOT install GCMs with a Julian date of 171 through 199. Return those modules according to Special Return Bulletin #G\_0000171850.

3. Locate the barcode label on the new GCM.

4. Determine the Julian date (1) as shown above.
  - If the Julian date (1) is 171 through 199, do NOT install the module. Obtain another module and perform the inspection again.
  - If the Julian date (1) is NOT 171 through 199, proceed to the Installation Procedure below.
