# Service Bulletin

Bulletin No.: PI0754A

**Subject:** Rear and Side Tempered Glass Spots (Quench Marks)

**Models:** 2014 and Prior GM Passenger Cars and Trucks

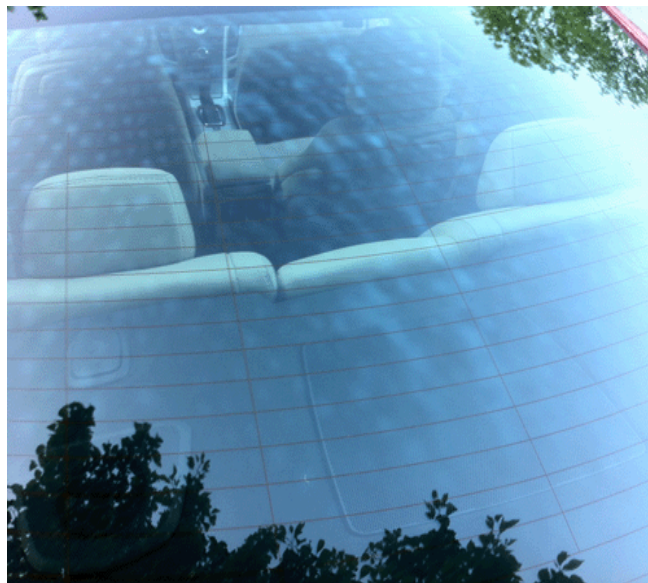
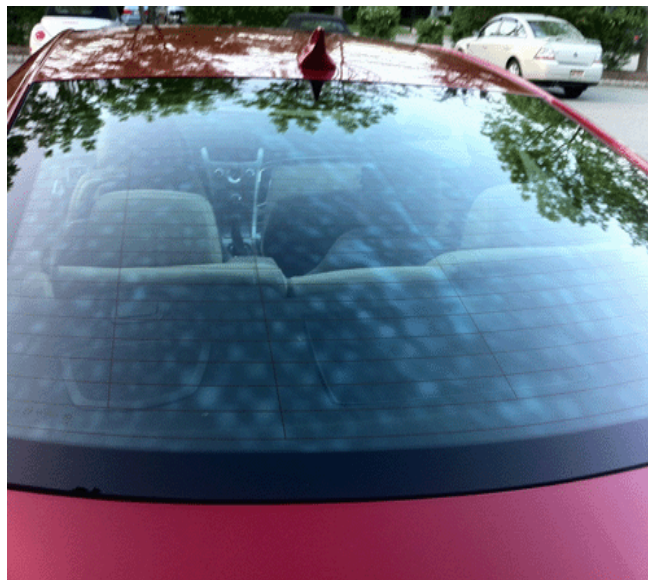
Some customers may comment on spots showing on the rear and side windows when the vehicle is in the sunlight. When wearing polarized glasses/sunglasses, these spots may be more magnified.

The spots are due to the manufacturing process and are “quench marks” in the glass. Quench marks are an unintentional side effect of the tempering process.

Technicians should explain to the customer that this is a normal condition and part of the manufacturing process for tempered glass. Do not replace the window(s) for this condition.

**Note:** This will not be seen on front windshields or laminated side glass.
