Service Bulletin

Bulletin No.: PI0291A

Subject: High Release Efforts on Driver or Passenger Seat Back Latch or Release Handle
Difficult to Operate

Models: 2010-2012 Chevrolet Camaro

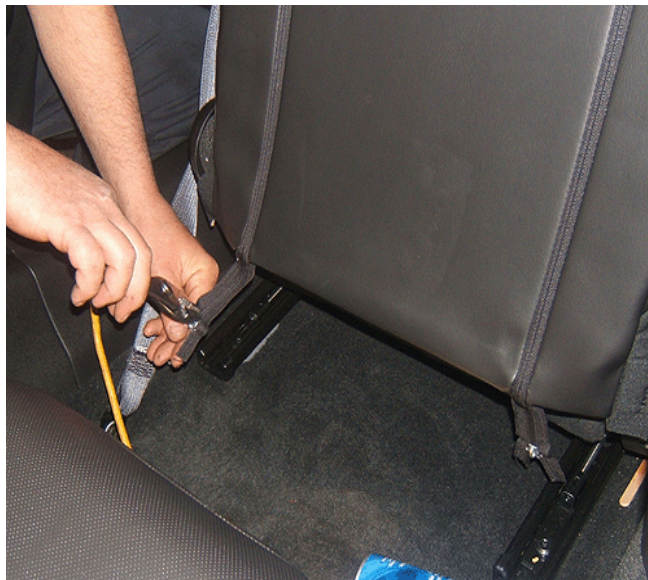
2540451

1. Move the driver's seat fully forward.
