Service Bulletin

Bulletin No.: PI0488A

Subject: Diagnostic Information for Transmission No Forward, No Reverse, Slips, Cracked/Split Fluid Filter

Models: 2010-2012 Cadillac CTS-V, Escalade Models
2010-2012 Chevrolet Avalanche, Camaro, Corvette, Express, Silverado, Suburban, Tahoe
2010-2012 GMC Savana, Sierra, Yukon, Yukon XL
Equipped with 6L80 or 6L90, 6-Speed Automatic Transmission (RPO MYC or MYD)

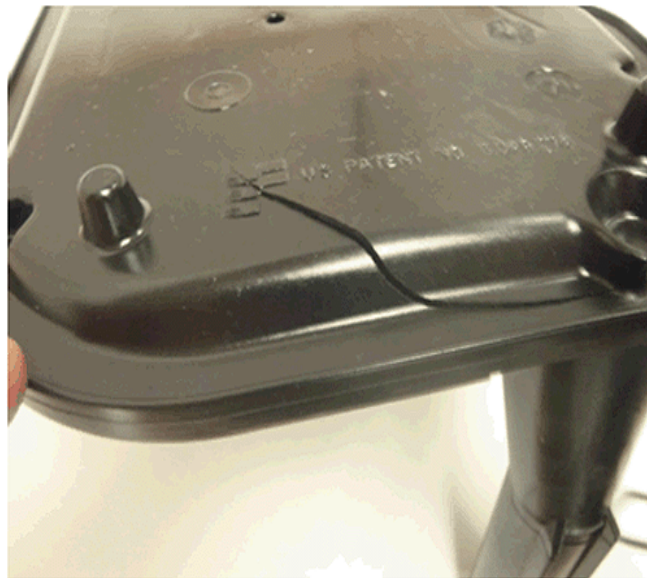
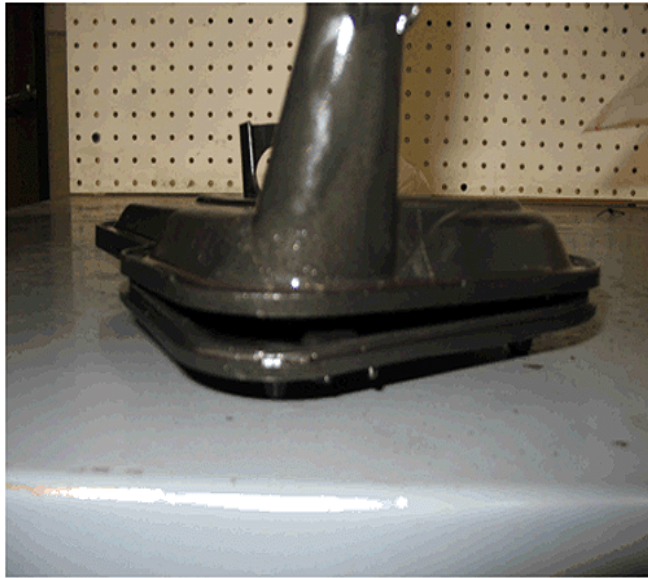
2665171

When diagnosing a confirmed condition of no forward or no reverse or slipping, be sure to thoroughly visually inspect the transmission fluid filter assembly. The filter may be cracked or split as shown in the photos below.

If a cracked or split filter is found, the fluid pump should be disassembled and inspected for possible damage. Inspect for any of the following conditions:

- Scored pump rotor or pump vanes
- Scored pump cover or pump rotor pocket
- Cracked pump slide

The transmission should also be evaluated for any possible distress to the clutches.
