PRELIMINARY INFORMATION

Subject: Diagnostic Information for No Forward, No Reverse, Transmission Slips

Models: 2010-2011 Cadillac CTS-V, Escalade Models
2010-2011 Chevrolet Avalanche, Camaro, Corvette, Express, Silverado, Suburban, Tahoe
2010-2011 GMC Savana, Sierra, Yukon, Yukon XL
Equipped with 6L80 or 6L90, 6-Speed Automatic Transmission (RPO MYC or MYD)

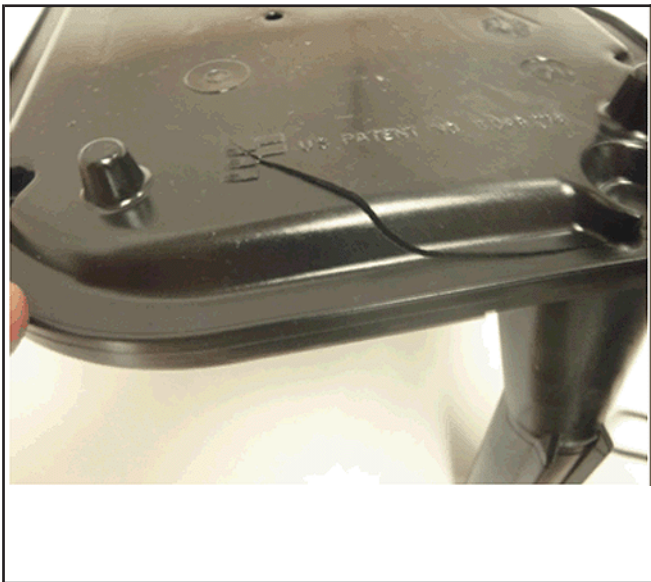
2665170

When diagnosing a confirmed condition of no forward or no reverse or slipping, be sure to thoroughly visually inspect the transmission fluid filter assembly. The filter may be cracked or split as shown in the photos below.

If a cracked or split filter is found, the fluid pump should be disassembled and inspected for possible damage.

Inspect for any of the following conditions:

- Scored pump rotor or pump vanes
- Scored pump cover or pump rotor pocket
- Cracked pump slide

The transmission should also be evaluated for any possible distress to the clutches.
