SB-10043373-3311

Title: One piece sunshade mounting bracket becomes loose or comes off the cab

Applies To: HPV style (DuraStar, TerraStar, WorkStar, TranStar, ProStar, LoneStar) day cabs, extended cabs, and travel crews built in Garland or Springfield between June 2010 and February 2012. This does not affect Escobedo built vehicles.

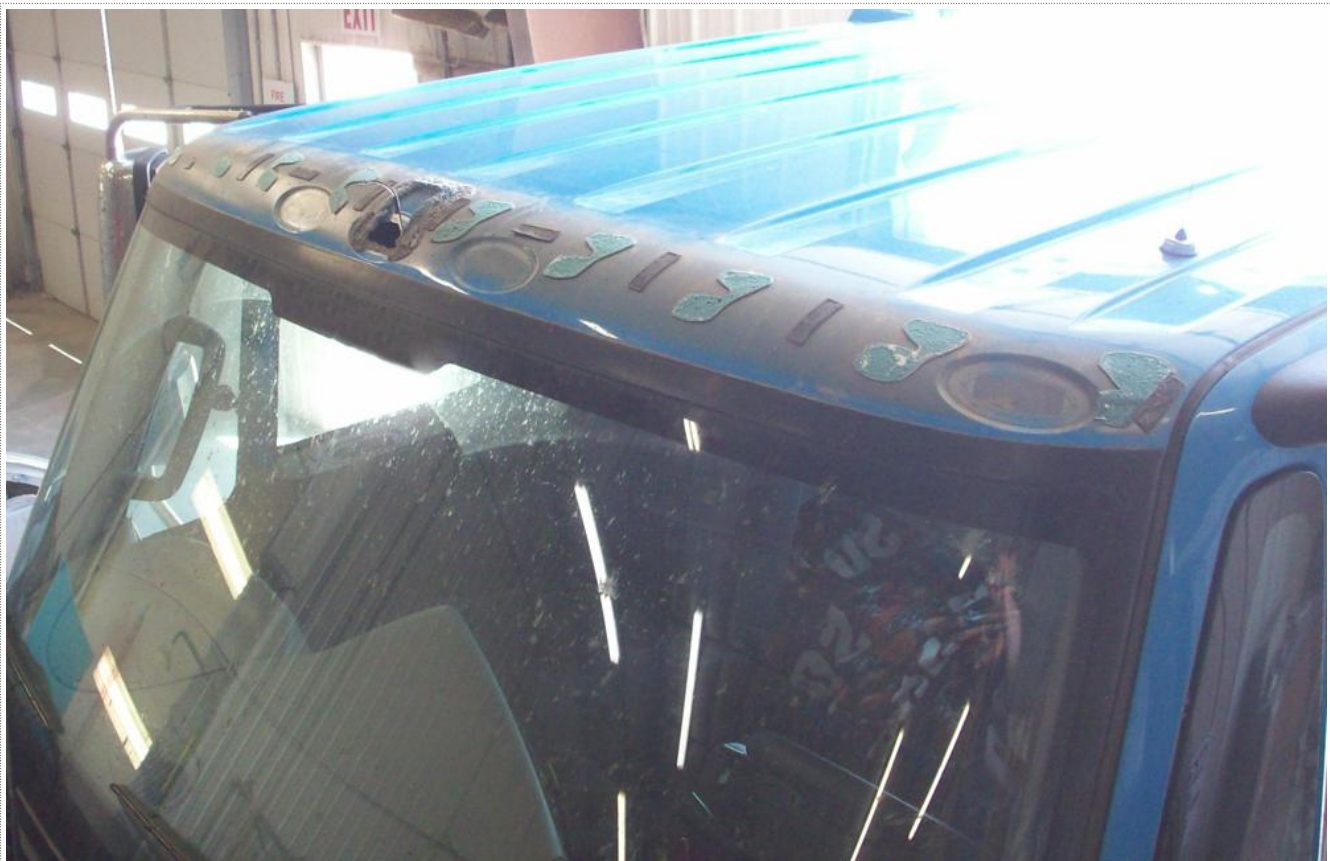
The sunshade mounting bracket has completely detached from the vehicle.

- For installation of the mounting bracket, remove any remaining adhesive from cab roof, prime/paint the attachment area, and reinstall the new mounting bracket using Lord Fusor 120, T20, or T21 SMC Repair Adhesive. Then seal the perimeter with an all weather adhesive/sealant such as SikaFlex 221.

- For removal and installation of the sunshade to the bracket [CLICK HERE](#)
- If the bracket has not come off yet but is loose or in the process of detaching, follow the above procedure to repair. If the old bracket is not damaged during removal, just remove the adhesive patches from the mounting surface and reuse, otherwise reinstall with a new mounting bracket.

- Note: The sunshade mount can be removed successfully by heating the sunshade mount with a small heating device while gently lifting the sunshade mount with trim removal tools. It is not necessary to remove the inner trim of the cab. CAUTION: DO NOT GET TOO CLOSE WITH THE SMALL TORCH OR HEAT GUN. DAMAGE TO THE PAINT WILL RESULT. PAINT REPAIRS WILL THEN HAVE TO BE MADE.

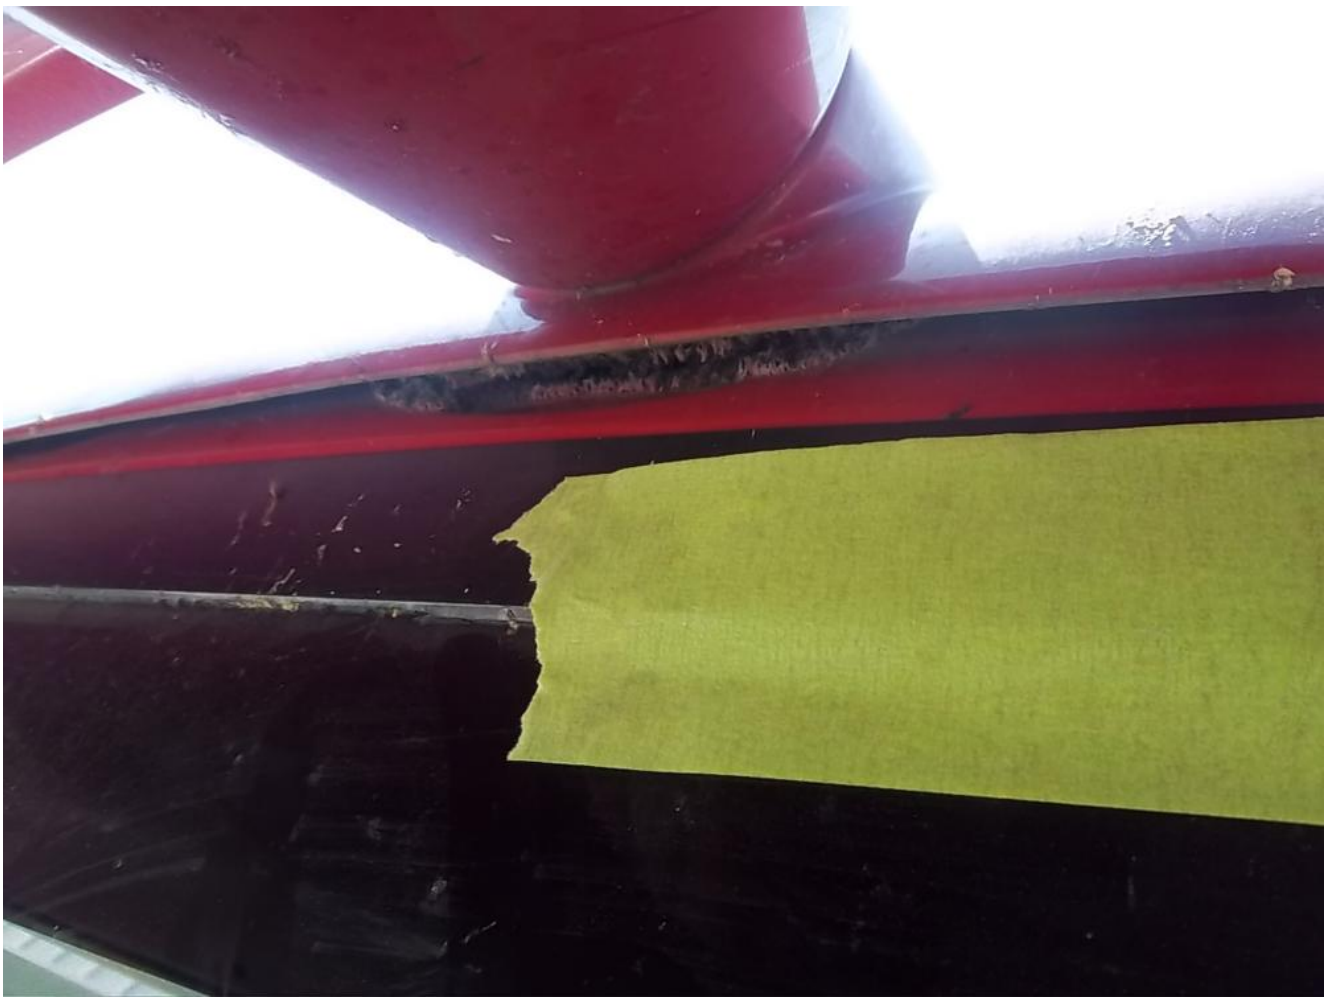
The sunshade mounting bracket is starting to come loose from the vehicle - the adhesive patch at the center mount is pulling apart.
