## TECHNICAL BULLETIN

UPS7412-2bNAS1  
20-DEC-12

## Update Prior to Sale: Front Differential Oil Leak

XJ (X351) All-Wheel Drive only

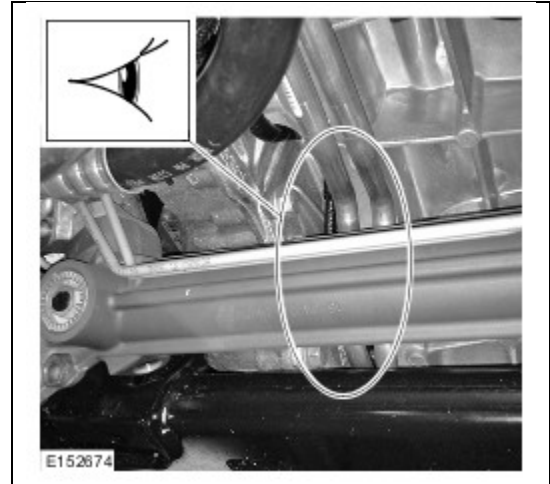
1. Start the engine and allow to idle for 10 minutes
2. **△ NOTE: Step must be carried out to make sure front differential oil is forced toward the engine oil pan**  
Drive the vehicle in a counter-clockwise direction for 30 seconds at speeds below 5mph.
3. Refer to Workshop Manual section 501-02 and remove the air deflector.
4. Inspect the joint between the front differential case and the engine oil pan.
  - If any signs of leakage are evident, the vehicle must be held until further notice.
  - If no signs of leakage are evident, the vehicle may be released for onward distribution / sale.
5. Refer to Workshop Manual section 501-02 and install the air deflector.
