# Ferrari North America

## Technical Information

| Bulletin #: | 2065 |

**Model Type:** FF (F151)  
**Model Year:** All Applicable  
**Subject:** Improving accessibility to battery conditioner connector

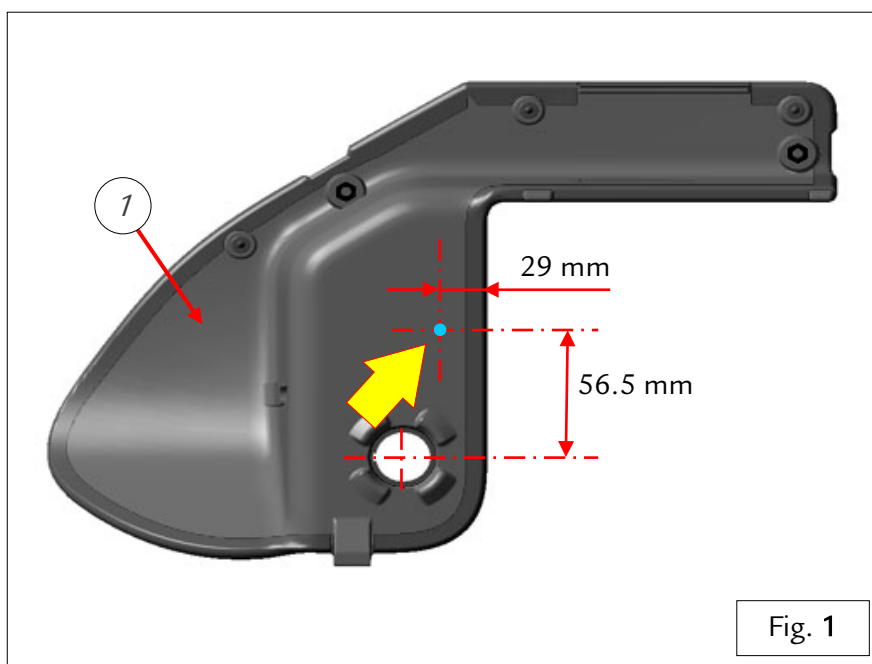
- Referring to the dimensions in the figure, mark the inner side of the taillight cover panel (1) in the position indicated – Fig. 1.

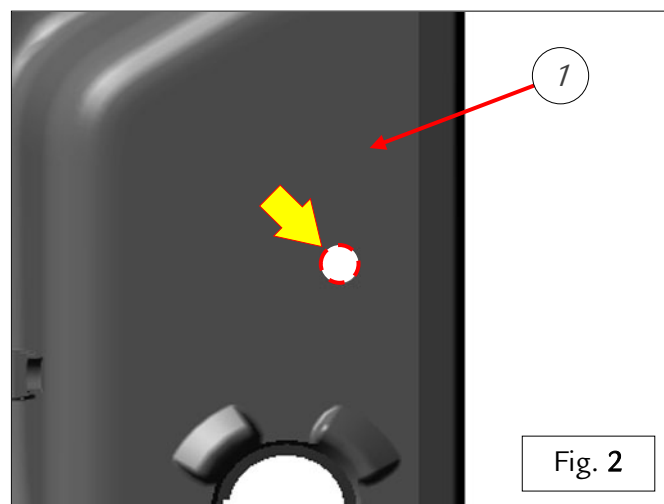
- Using a drill with a **5 mm** bit, cut a through hole in the position marked previously on the inner side of the taillight cover panel (1) – Fig. 2.

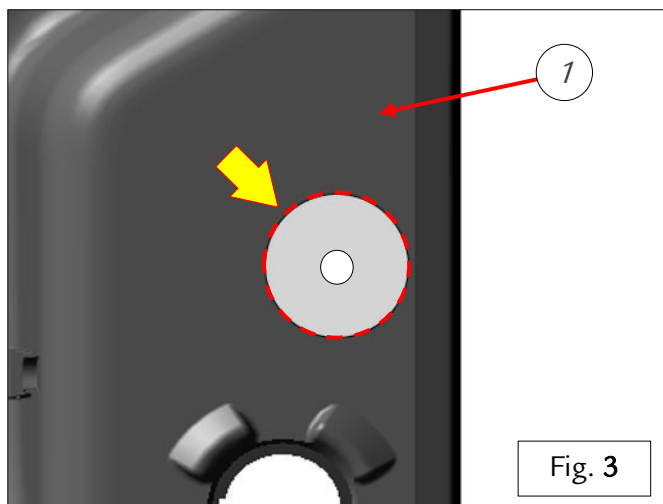
- Using a drill with a **34.5 mm** hole saw, cut a hole as indicated **without cutting through the leather trim**, inserting the pilot bit in the hole made previously on the inner side of the taillight cover panel (1) – Fig. 3.

**Note: DO NOT cut through the leather trim of the taillight cover panel.**

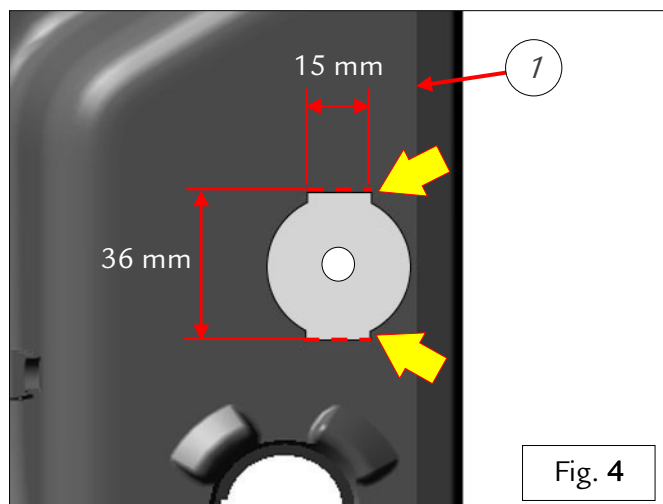
- Using a flat file and referring to the dimensions in the figure, file the two notches indicated in the circumference of the hole cut in the inner side of the taillight cover panel (1) – Fig. 4.

**Note: DO NOT cut through the leather trim of the taillight cover panel.**

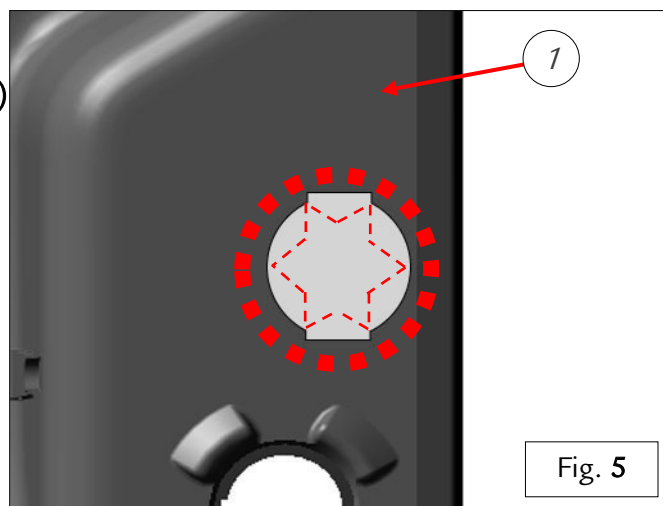
- Using suitable scissors, cut out the star shape indicated by the dotted lines in the leather trim of the taillight cover panel (1) – Fig. 5.
- Using a hot glue gun, apply a bead of hot glue where indicated by the dotted circle in the figure on the inner side of the taillight cover panel (1) – Fig. 5.

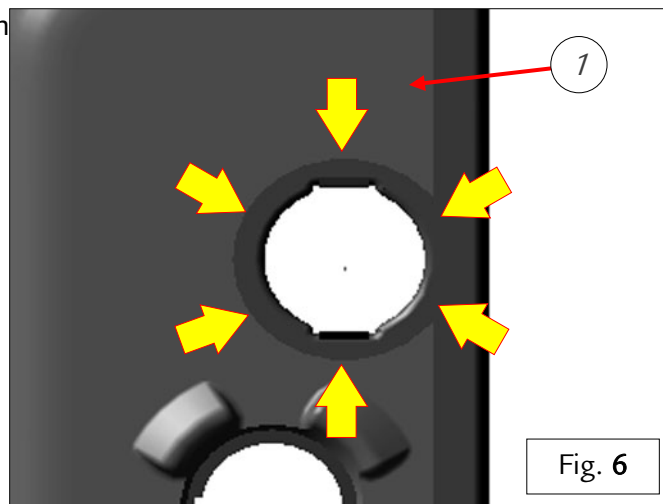
- Fold the indicated flaps of leather through the hole and onto the inner side of the taillight cover panel (1), affixing onto the glue applied previously – Fig. 6.

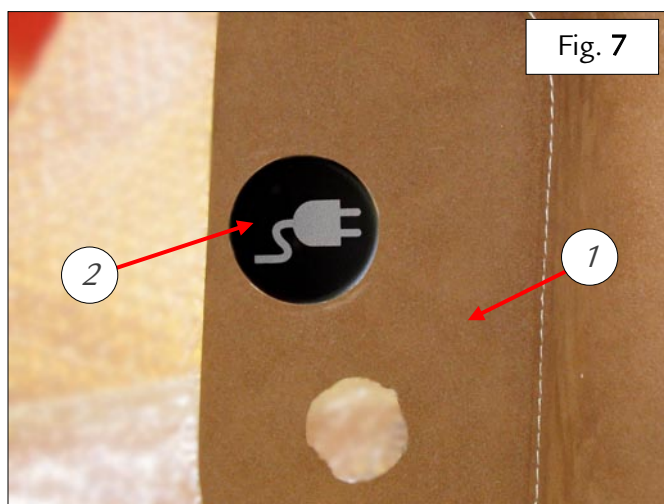
- Fit the battery conditioner identification cap **Part No. 84969300 (2)** in the respective hole made previously on the outer side of the taillight cover panel (1) – Fig. 7.
