| <b>HYUNDAI</b> NEW THINKING.<br>NEW POSSIBILITIES.<br><br><b>Technical Service Bulletin</b> | | GROUP | NUMBER |
| | | <b>AUTOMATIC TRANSMISSION</b> | <b>13-AT-008</b> |
| <b>SUBJECT:</b> | <b>AUTOMATIC TRANSAXLE SOLENOID DTC</b><br><b>P0741, P0743, P0748, P0753, P0758, P0763, P0768, P0773, P1778 AND P2709</b> | | |
| <b>Description:</b> Do not replace the transmission for solenoid DTC listed above. Instead, follow the repair procedure and replace the related part. | | | |

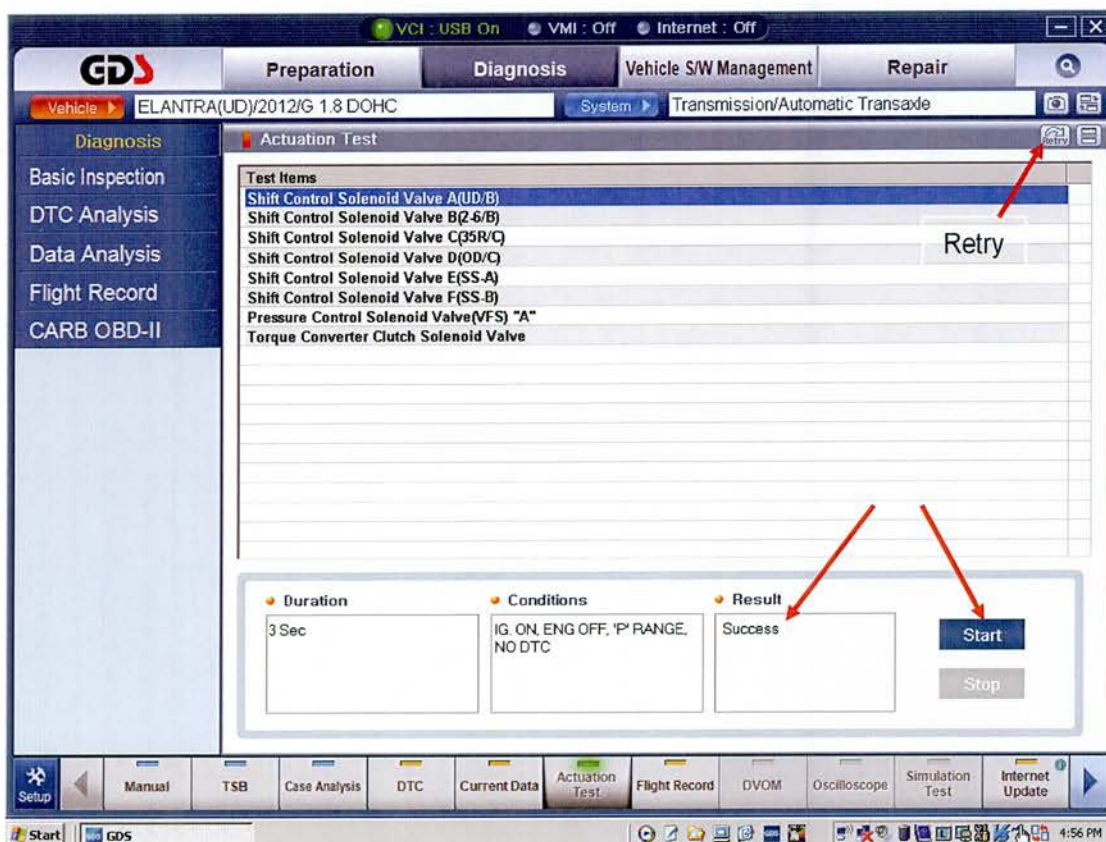
Press the "Start" button and look for a "Success" indication.

3. If the test results show:
  - "Success" – The GDS requested the TCM to activate the solenoids. Use chassis ears or stethoscope to listen for solenoid operation. If the solenoids are audible, the harness currently has no open/short circuit. Go to Step 5.
  - "Failure" - The GDS did not request the TCM to activate the solenoids. Click on the "Retry" button on the top right of the screen. If "Failure" is displayed again, go to Step 4.
4. Visually check the wiring harness between the PCM and transmission for a damaged wire or short circuit to ground. Check for a damaged pin or pin not fully inserted into the connector.
  - If damage exists, repair or replace the ECM control harness and drive the vehicle to confirm the repair.
  - If not, go to Step 5.

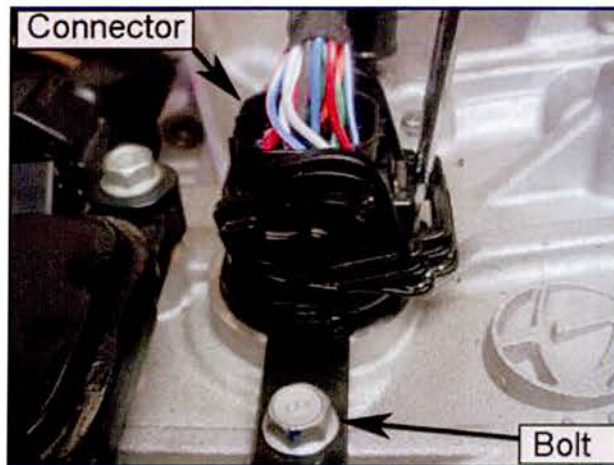
6. Record the radio stations.  
 Remove the battery and battery tray.
7. Remove the undercover below the transmission.
8. Drain the radiator and remove the lower radiator hose from the radiator, if necessary.  
 Drain the ATF.
9. Use a screwdriver to release the tab and remove the solenoid connector on top of the case.

Remove the bolt that secures the connector and push the connector into the transmission.

Disconnect the vent hose on the top of the oil pan.

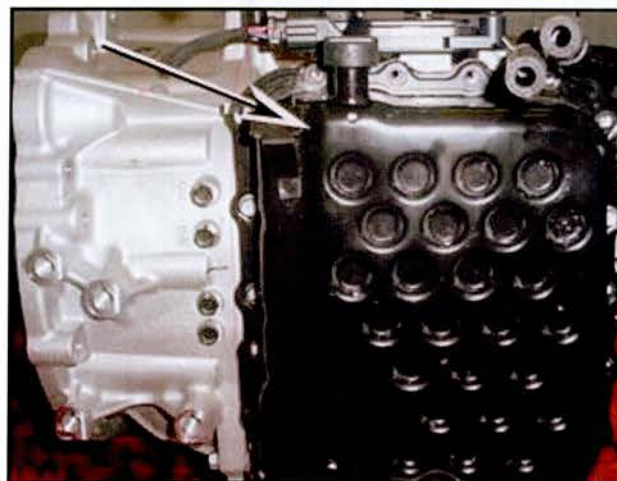
10. Remove the oil pan bolts and remove the pan.

Use rubber hammer to tap the oil pan cover on a corner until the cover is loose.

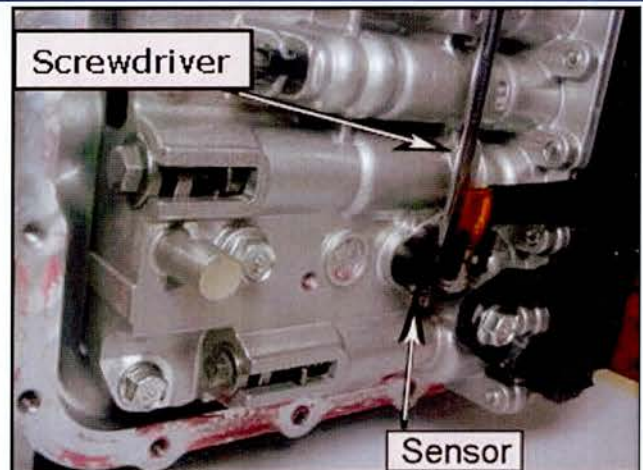
11. Use a small screwdriver to pry the connector from the oil temperature sensor.

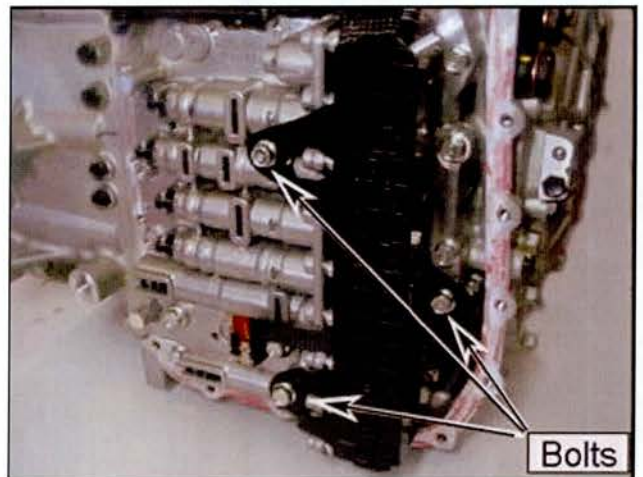
12. Remove three bolts to the solenoid valve connector.

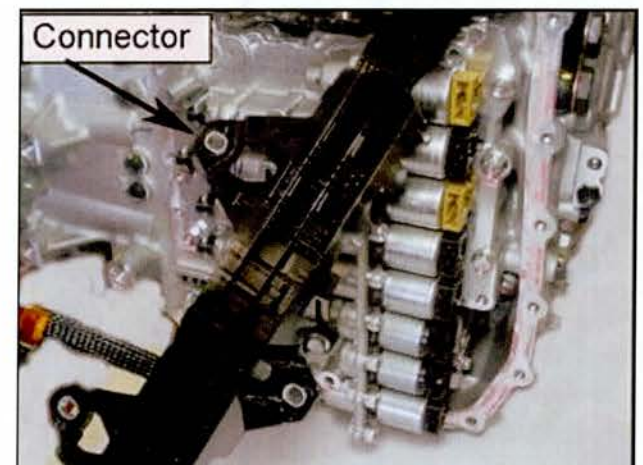
13. Pull the solenoid connector outward and move the connector out of position.

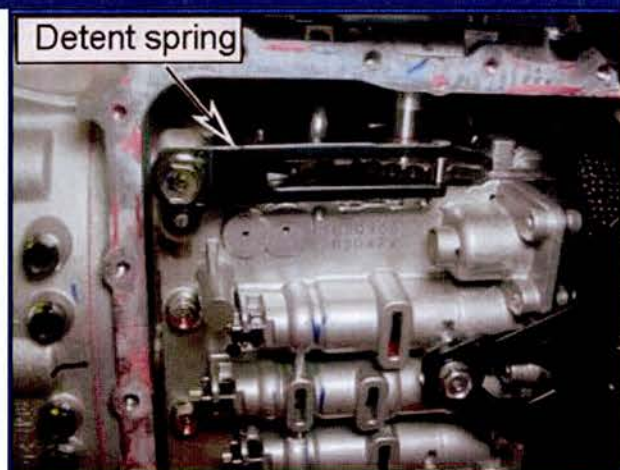
14. Remove the bolt that secures the detent spring and remove the spring.

Torque: 8~11 lb.ft (1.2~1.6 kgf.m)

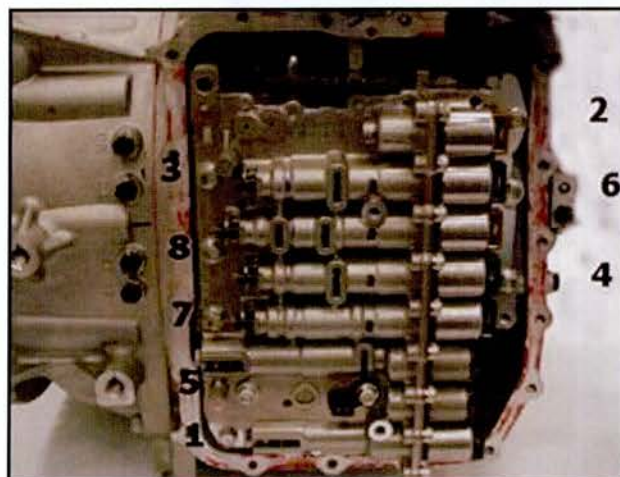
15. Remove the valve body bolts in the order shown and remove the valve body.

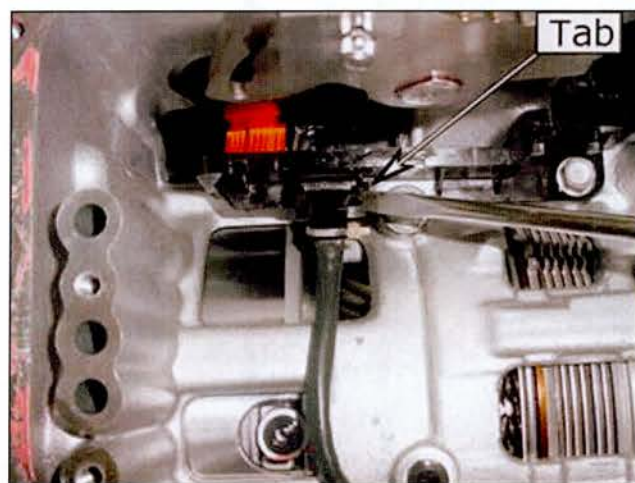
16. Use a screwdriver to depress the locking tab and pull outward on the connector to the input and output speed sensor.

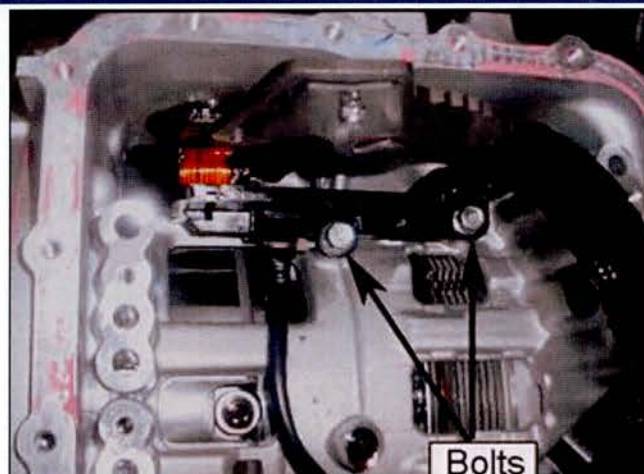
17. Remove two bolts that secure the valve body harness to the case.

Pull the connector downward out of the case.

Install a new harness and insert the connector into the case. Attach the retainer and bolt on top of the case as shown in Step 9.

Install the bolts that secure the harness.

Torque: 7~9 lb.ft (1.0~1.0 kgf.m)

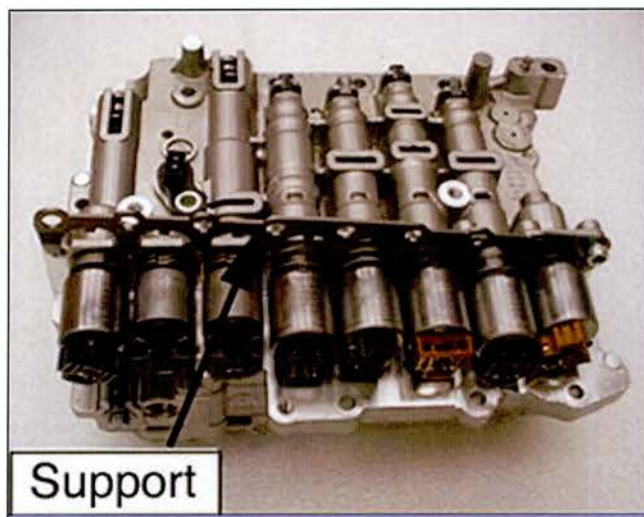
18. Use a 5mm hex socket and remove 9 Allen bolts that secure the solenoid support. Remove the solenoid support.

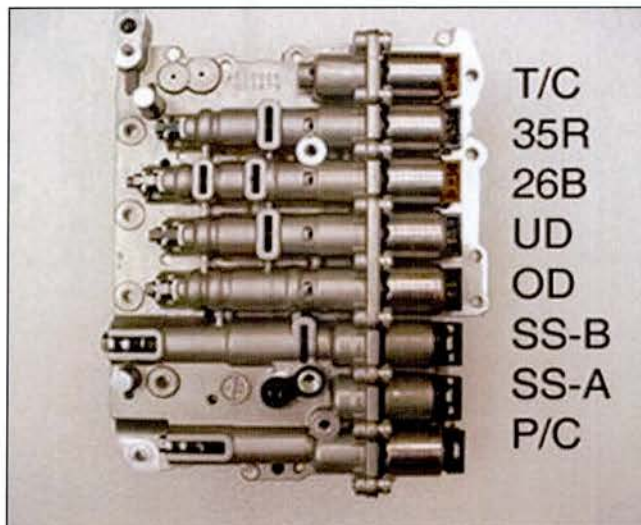
19. Refer to the DTC recorded in Step 1 and replace the related solenoid

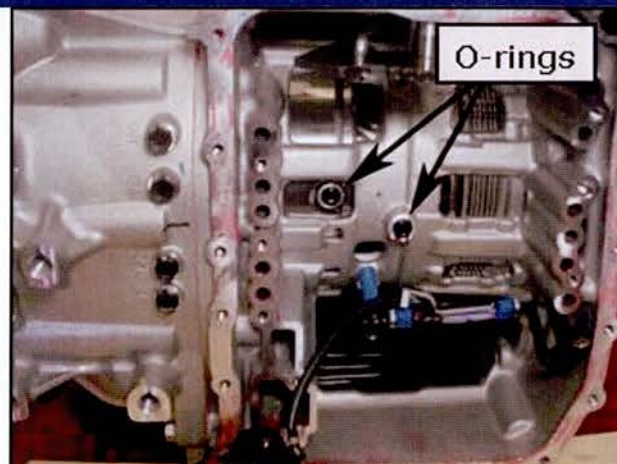
20. Confirm the O-rings are installed correctly in the case.

Reconnect the input and output speed sensor connector to the harness.

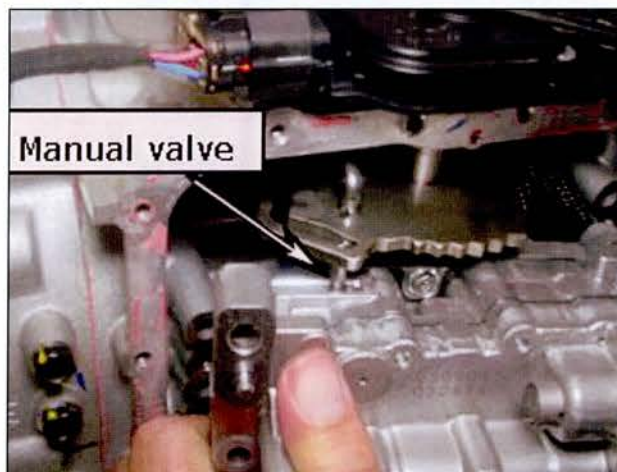
21. Align the manual shaft to the shift lever and install the valve body.

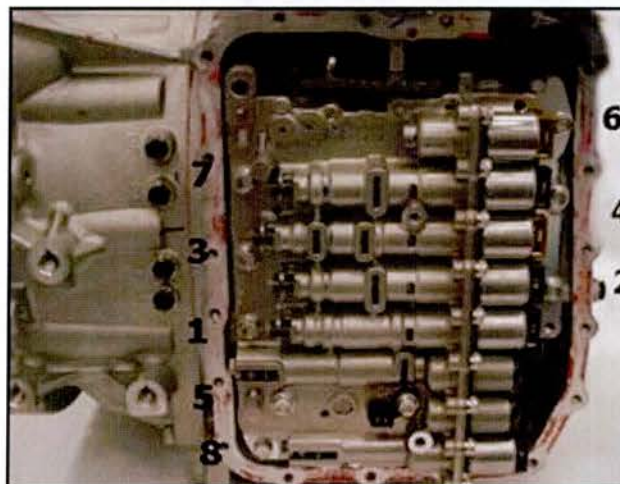
22. Install the valve body bolts and torque the bolts to specification in the order shown.

Toque: 7~9 lb.ft (1.0~1.2 kgf.m)

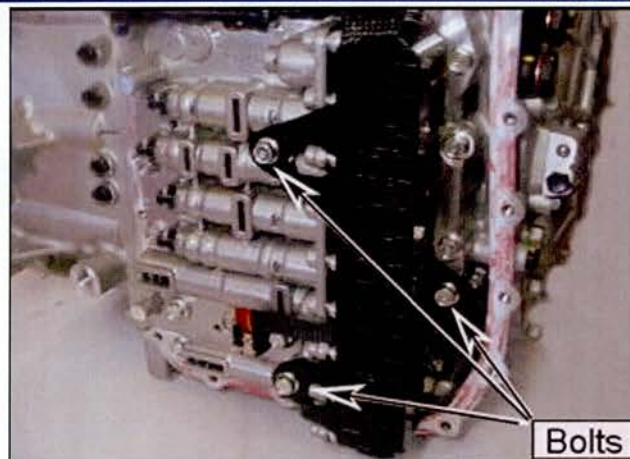
23. Reconnect the solenoid harness to the solenoids and oil temperature sensor.

Install the bolts to the solenoid harness connector and torque to specification.

Torque: 7~9 lb.ft (1.0~1.2 kgf.m)

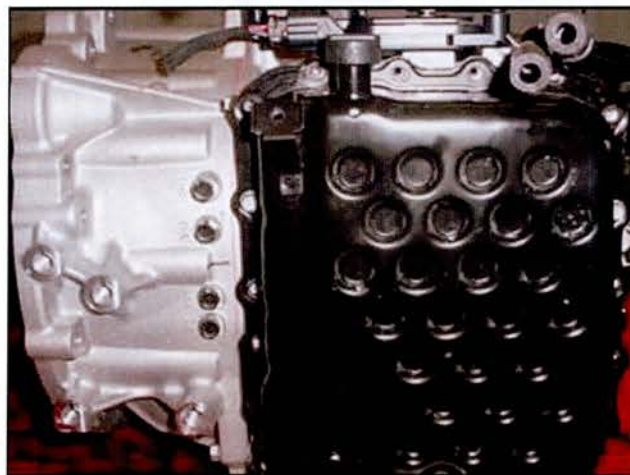
24. **STEEL OIL PAN:**

Apply Permatex Ultra Gray Sealer or Hyundai Ultra Gray Gasket Sealer, P/N 00232-19039, to the oil pan and reinstall the pan.

**PLASTIC OIL PAN:**

Install a new gasket to the oil pan and reinstall the pan.

Tighten the bolts to specification.

Torque: 10~12 lb.ft (1.4~1.6 kgf.m)

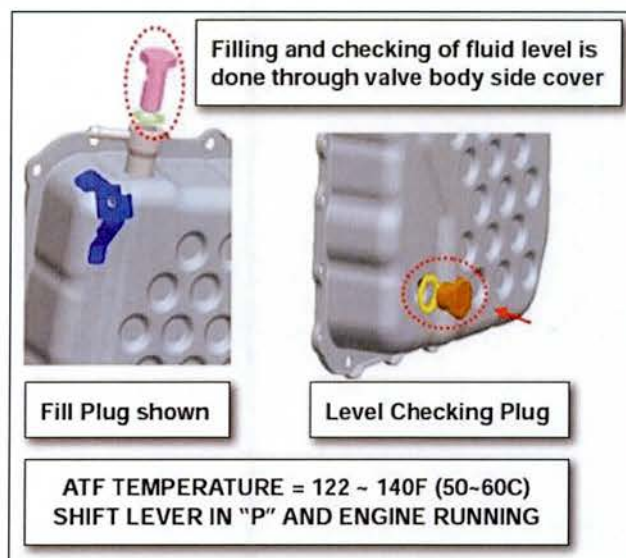
Use a funnel to add approximately 5~6 quarts of SPH-IV ATF through the fill plug opening. Reinstall the fill plug.

Attach the GDS to the DLC and select vehicle, A/T menu, Current Data and "Oil Temperature Sensor".

Start the engine and shift to Park. When the ATF is 122°F~140°F (50~60°C), remove the level checking plug. The level is correct when oil flows out of the level checking plug in a thin steady stream.
