**NUMBER:** 23-018-13**GROUP:** Body**DATE:** May 09, 2013

Windshield Wiper Vibration

This bulletin involves removing and replacing the wiper module linkage bolts.

2013 (JK) Wrangler

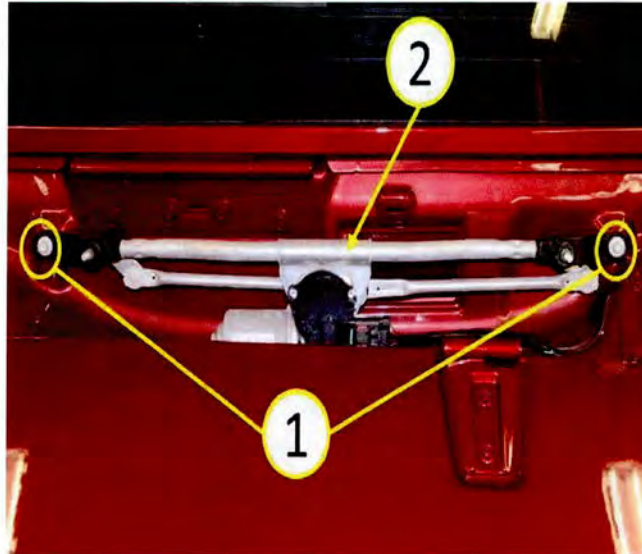
Fig. 1 Front Wiper Module

Windshield wiper blade vibration.

1 - Wiper Module Linkage Bolts

2 - Wiper Module

1. Remove and replace the wiper module linkage bolts (Fig. 1) with p/n 06104370AA. Refer to the detailed service information in DealerCONNECT> TechCONNECT> Service Information tab> 08-Electrical> 8R - Wiper/Washers> LINKAGE, Wiper Arm> Removal/Installation.
