**NUMBER:** 26-001-13 REV. A

Dodge Dart Racetrack Lighting Customer Initiative

This bulletin involves removing and replacing the center rear lamp secured to the decklid assembly after disclosing promotional pricing the customer will be responsible for.

2013 (PF)

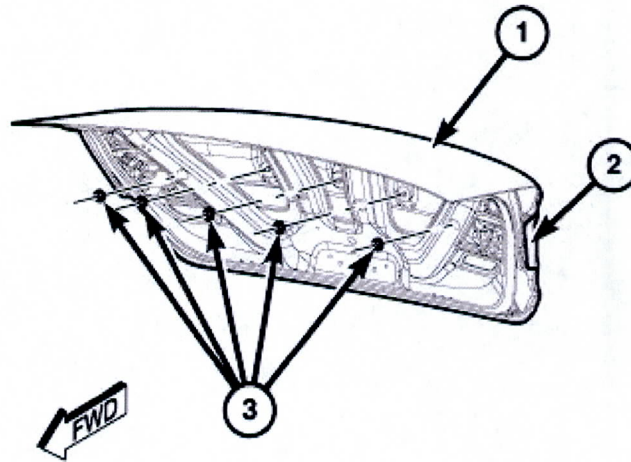
**Fig. 4 Center Decklid Lamp Fasteners**

- 1 - Decklid
- 2 - Center Tail Lamp
- 3 - Five Fasteners

7. Remove the decklid insulator/trim panel (1) (Fig. 3).
8. Remove the five nuts (3) that secure the center tail lamp (2) to the inside of the deck lid inner panel (Fig. 4).

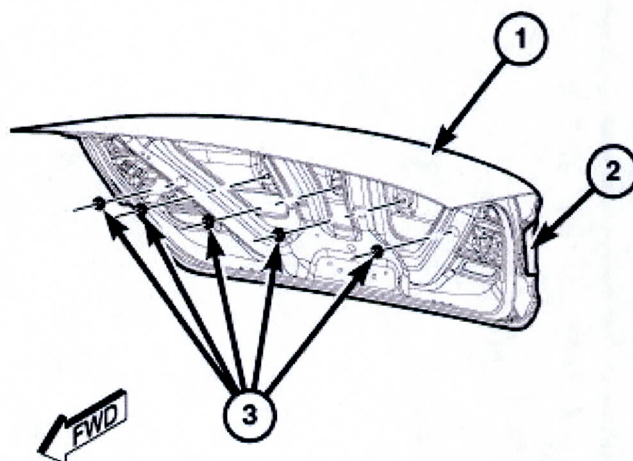
**Fig. 8 Center Decklid Lamp Fasteners**

- 1 - Decklid
- 2 - Center Tail Lamp
- 3 - Five Fasteners

- 
14. Position the new center tail lamp unit (1) into the lower deck lid (2) lamp opening (Fig. 7).
  15. Using hand pressure, press firmly and evenly on the two outboard ends of the center tail lamp to seat the retention features into the deck lid inner panel.
  16. From the inside of the deck lid (1), install and tighten the five nuts (3) that secure the center tail lamp (2) to the deck lid inner panel. Tighten the nuts securely (Fig. 8).
