SB-10052402-4902

Title: Bus Entrance Door Solutions

Applies To: CS, IC, BE, CE, FE, RE Buses, Units Built Prior to Sept 15, 2011.

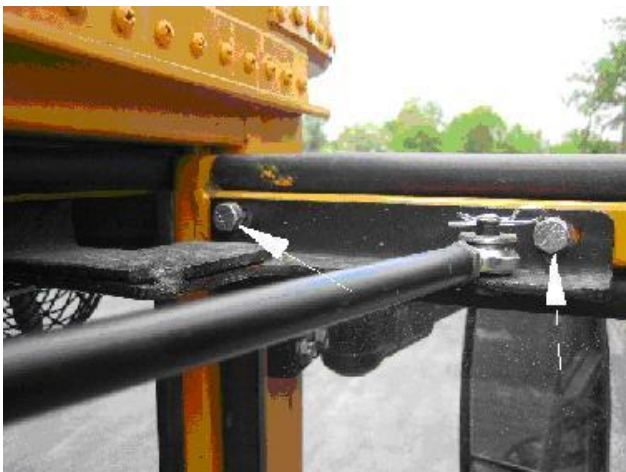
SYMPTOM #1

- Forward door bracket pulled loose from the door
- Reference TSI 06-47-01
- Reinforcement kit to repair door and bracket mounting

Kit 2589963C91 can be used on all models, 2005 to current, to repair doors damaged as a result of incorrect adjustment or other damage that results in bracket attachment point failures. Doors with excessive damage should be replaced.

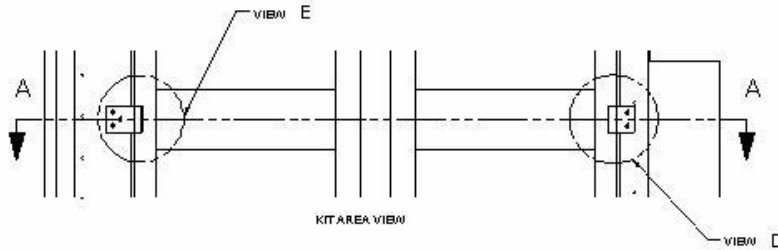
SYMPTOM #2

- Entrance doors, hinge edge, bow out while driving
- Complaints of the vertical seal folded into hinge area or not sealing
- Stabilizer is added to the center of the door to reduce door flex

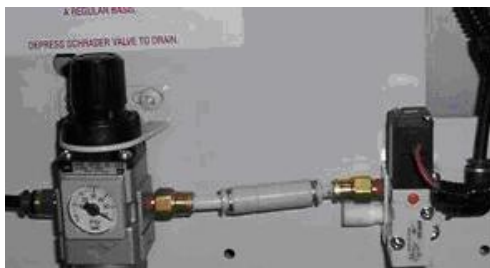
SYMPTOM #3

- Entrance doors, air cylinder controlled, partially open while driving
- Complaints of the pressure regulator has been adjusted and issue still remains
- Air door check valve kit can be added to increase cylinder static pressure
