SB-10052405-5360

Title: Bus Under Seat and Rear Wall Mounted Heater Ground Circuit**Applies To: CS, IC, FE, RE****DESCRIPTION**

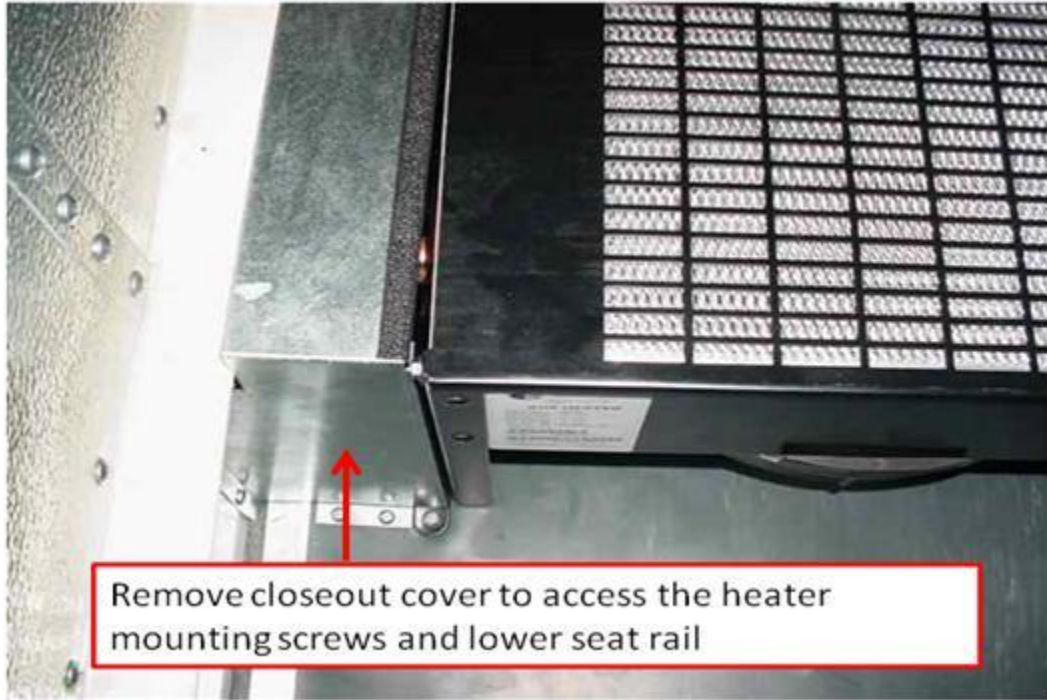
Under seat and rear wall mounted passenger heater blower motors work intermittently.

Pre 05 conventional models, RE built prior to Jan 2010, and all FE utilize the heater case and mounting screws to complete the blower motor ground circuit. This installation can result in a poor ground resulting in intermittent blower operation.

Prior to condemning a blower motor as a failed product, test the motor with a known good ground. If the motor operates correctly, the following actions can be taken to ensure a positive ground.

- Spot face the housing mounting screw flange
- Install mounting screws long enough to penetrate the metal floor (units equipped with a plywood subfloor) or;
- Install a ground strap from a mounting screw to a point on the lower seat rail

The above repairs should be performed on the wall side heater mounting points.
