Advanced Technical Information

1303 1726/9752

Oil Ingress Into The Engine Wiring Harness

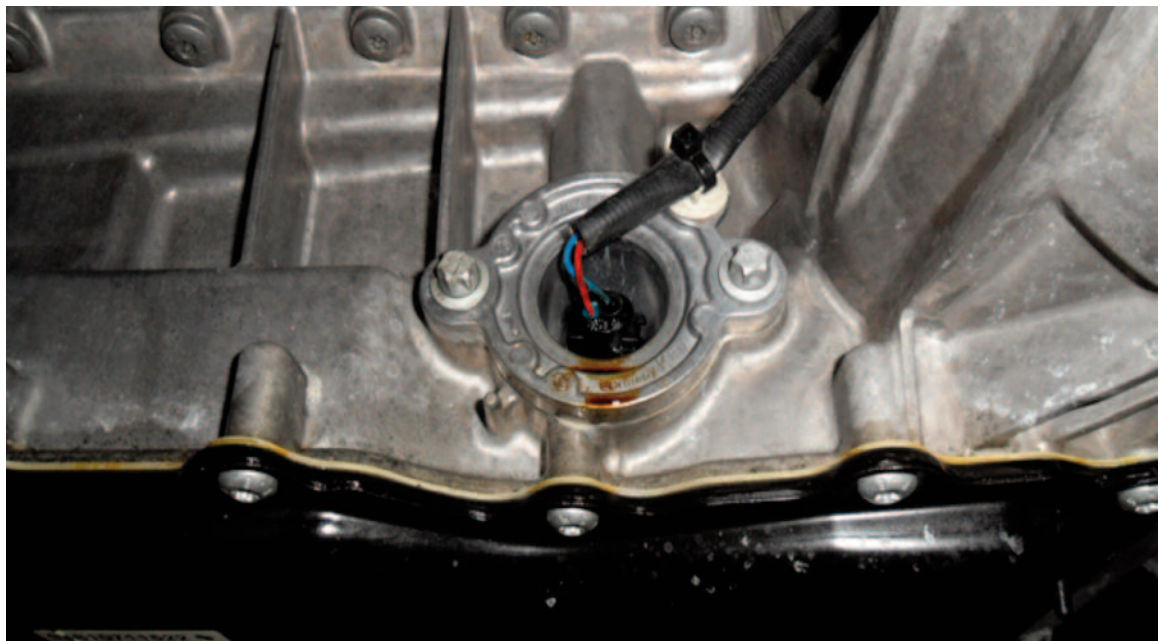
Vehicle Type:	Cayenne V8, Panamera (except hybrid) and Sports Cars
Model Year:	Cayenne: 2008 and up, Panamera 2010 and up, Sports Cars 2009 and up.
Part Number:	Various
Issue:	Oil in the wiring harness.
Information:	If oil is found in the engine wiring harness during a repair, the wiring harness and all the affected components (including the oil pump control valve) must be replaced.
