PREVOST

WARRANTY BULLETIN

WB13-32

DATE :	JUNE 2013	SECTION :	04 - Exhaust
EXPIRATION:	JUNE 2015		
SUBJECT :	NOX SENSOR REPLACEMENT & SOFTWARE UPDATE

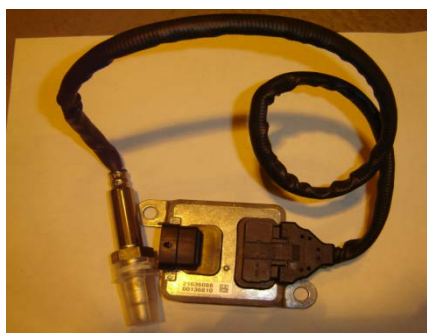
1. Open the SCR access door.
2. Write down new electronic module serial number before installing.

(Located at the back of the electronic module).

3. Replace NOx sensor 21636088 by 22014032
4. Tighten sensor to 37 lbf-ft
5. Tighten mounting bolts to 7 lbf-ft (89 lbf-in)

6. Support with clips and cable ties
