**EGR Temperature Sensor Routing**  
**VAH, VHD, VN**  
**D13H**

**FSB 293-022, EGR Temperature Sensor Routing**

(August 2013)

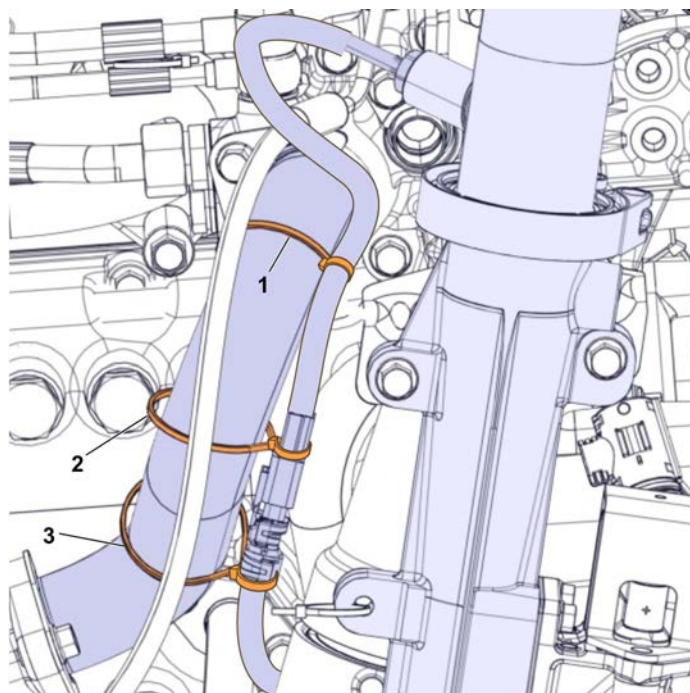
W2083701

- 1 Tie attaches 76 mm (3 in) above the back shell on the temperature sensor harness.
- 2 Tie attaches between the back shell and the temperature sensor connector.
- 3 Tie attaches directly below the back shell on the engine harness side.

In the event that an EGR temperature sensor replacement is required on a VOLVO D13H engine, a new routing configuration is required. The new configuration requires three double loop cable ties (part number 8079360) to secure the new EGR temperature sensor connector directly to the coolant pipe. On previous installations, the venturi pipe was a mounting point and only two ties were required.
