**SB-10053611-2339**

## **Service Campaign 63-06** **Second Notice**

**SUBJECT:** Slideout control module upgrade.

# Service Campaign, 63-06 Slide Control Module Update

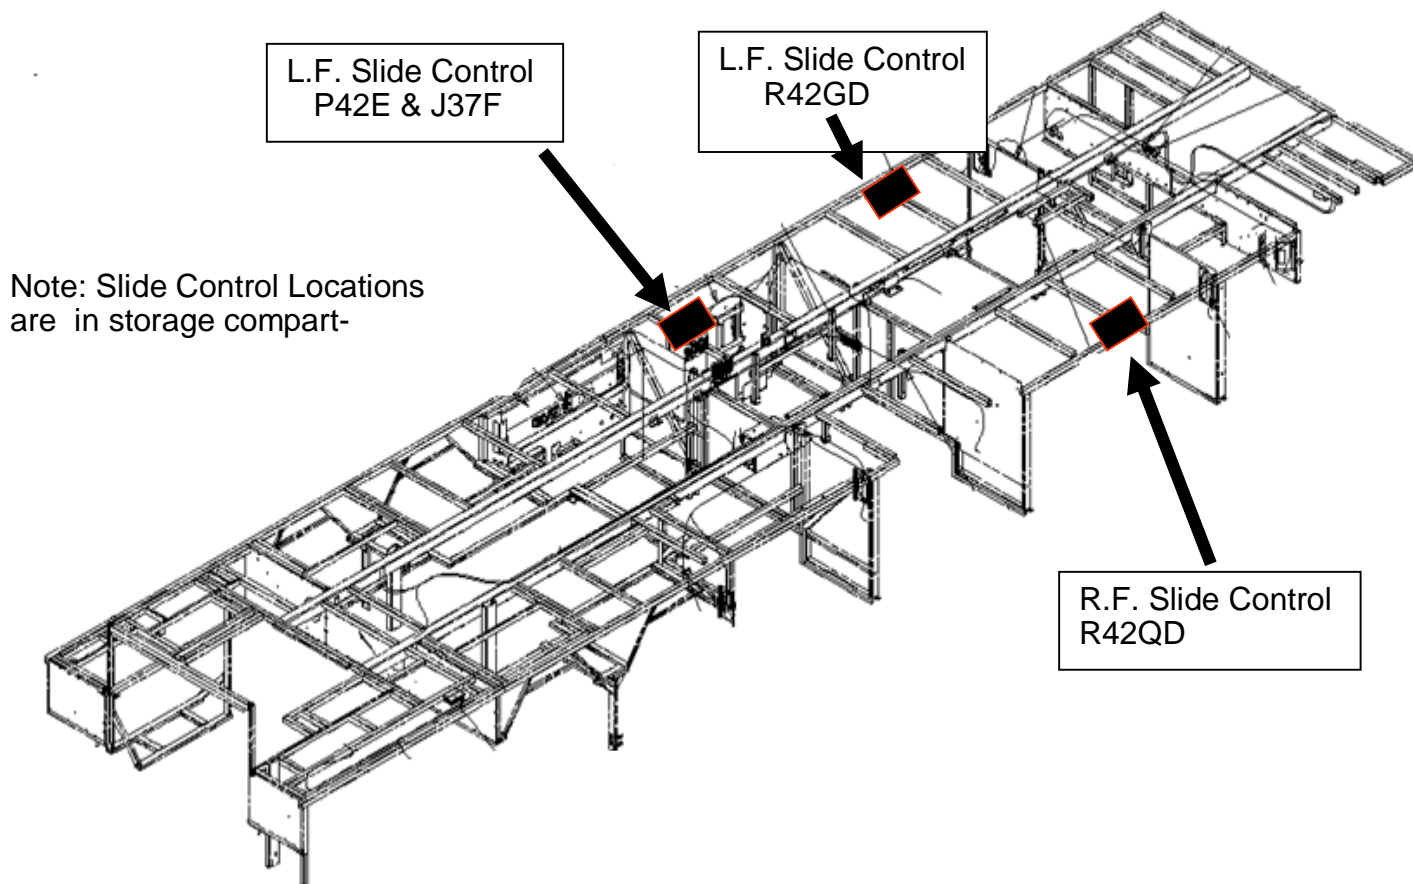
## Procedure to manually resynchronize Schwintek InWall Slideout

1. Extend slideout. When one end of slideout contacts wall there will be delay and then the side that needs to catch up will extend until it contacts wall.
2. Push "In" button, then "Extend" button to make sure slideout is fully extended.
3. Push "In" button one second, then "Extend" button and hold until no noise is heard. This should complete resynchronization.

1. Locate & replace slideout control with updated 8 amp control from campaign kit. (LCI # 326876).
2. Resynchronize slideout.
