HYUNDAI NEW THINKING. NEW POSSIBILITIES.	GROUP	NUMBER
	CAMPAIGN	13-01-032
	DATE	MODEL
	JULY 2013	SANTA FE (NC)
SUBJECT BLOWER PWM MODULE REPLACEMENT (SERVICE CAMPAIGN TP9)

Description: This bulletin provides the procedure to replace the blower PWM module for Santa Fe (NC) vehicles equipped with the Dual Automatic Temperature Control A/C system.

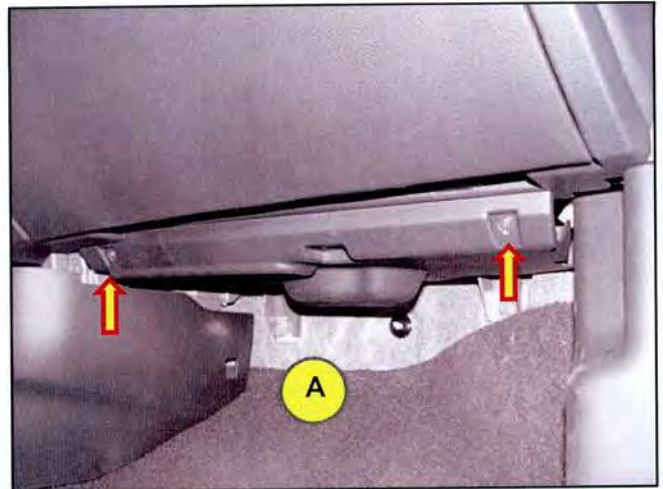
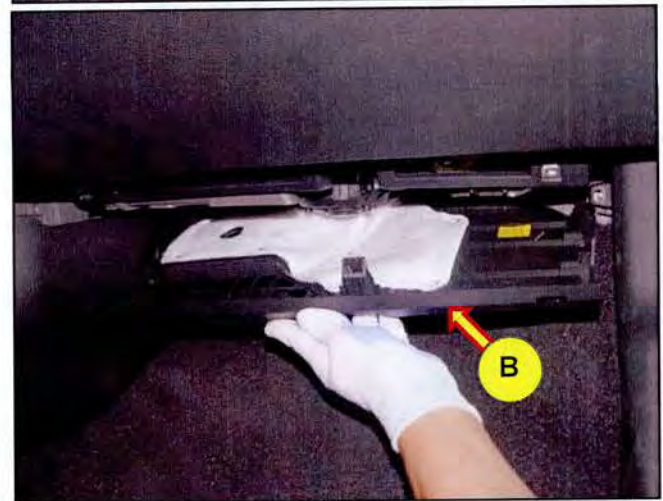
1. Remove the mounting screws (A), and then remove the crash pad under cover (B).

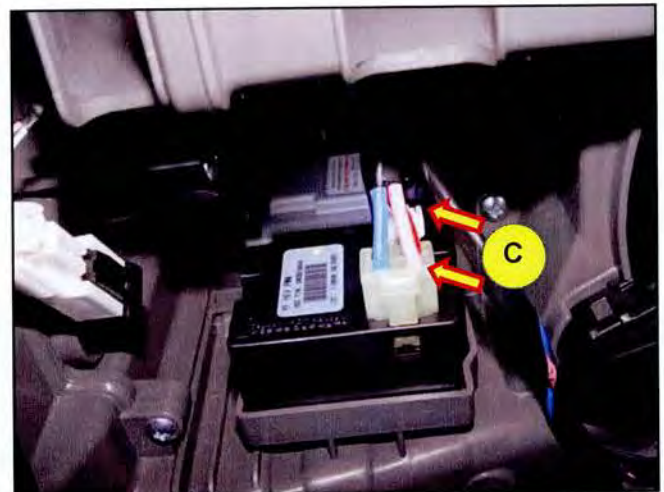
2. Disconnect the blower PWM module connectors (C).

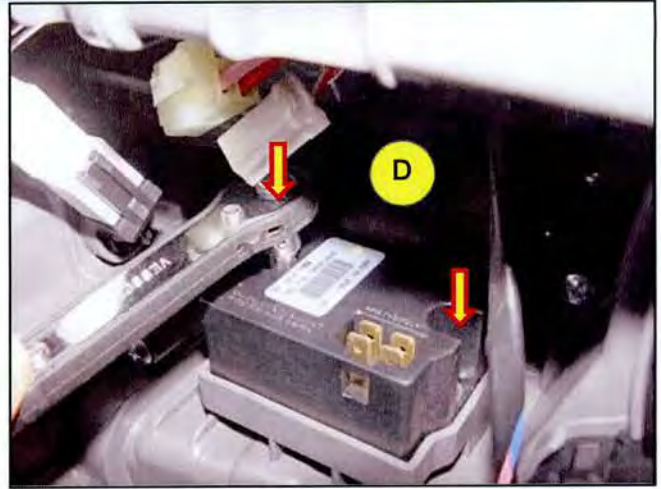
3. Remove the mounting screws (D), and then remove the blower PWM module (E).

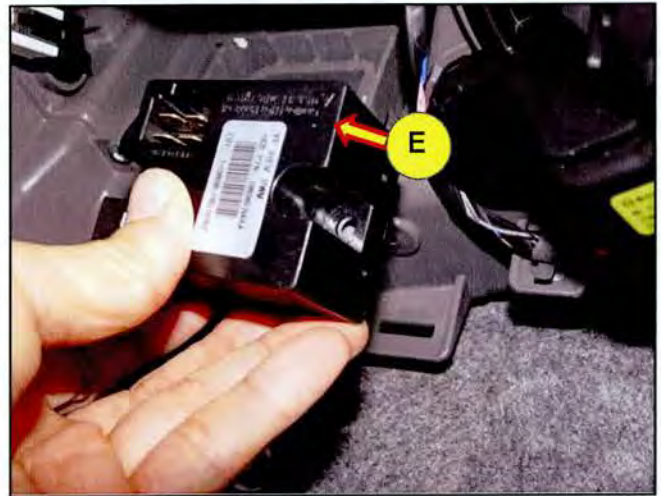
4. Install the new blower PWM module (yellow colored label part as shown in page 1) in the reverse order of removal.
5. Operate the A/C blower to verify proper system operation.

Part Name	Part Number		New Part Identification
	Previous	New	
BLOWER PWM MODULE	 	 	New part has a yellow colored label.
	97235-4RAA0	97235-4RAA0QQH
