Applies To: **2010-12 Crosstour V6** – Check the iN VIN status for eligibility

October 08, 2013

Warranty Extension: MIL Comes On With DTCs P0301 Through P0304

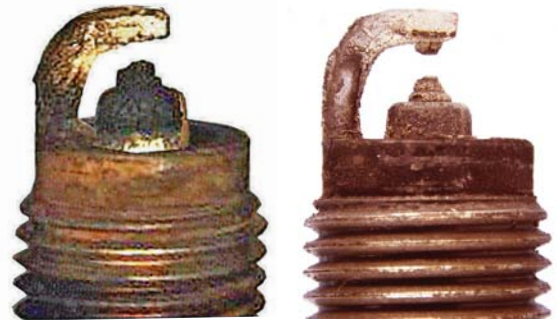
NOTE: Below are examples of good and fouled spark plugs.

GOOD

NO GOOD

3. Remove and check spark plug(s) on the affected cylinders (example: if P0301 is stored, check the spark plug on cylinder No. 1).
 - If the spark plug(s) are not fouled, this bulletin does not apply. Continue with normal troubleshooting.
 - If this vehicle has any of the above DTCs, the spark plug(s) are fouled, and the software is an earlier version, go to REPAIR PROCEDURE A.
 - If this vehicle has any of the above DTCs, the spark plug(s) are fouled, and the software is a current or later version, go to step 4.

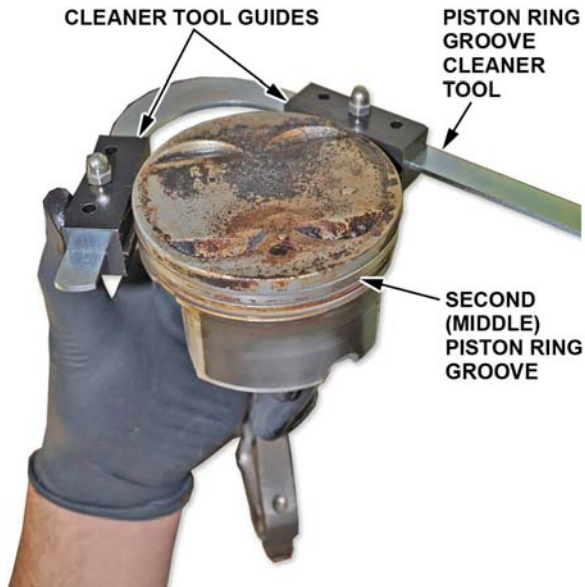
2. Spray the piston head and piston ring grooves thoroughly with Honda throttle plate cleaner.
3. While holding the piston upright in your left hand, take the piston ring groove cleaner tool in your right hand and line up the cleaner tool guides with the second (middle) piston ring groove.

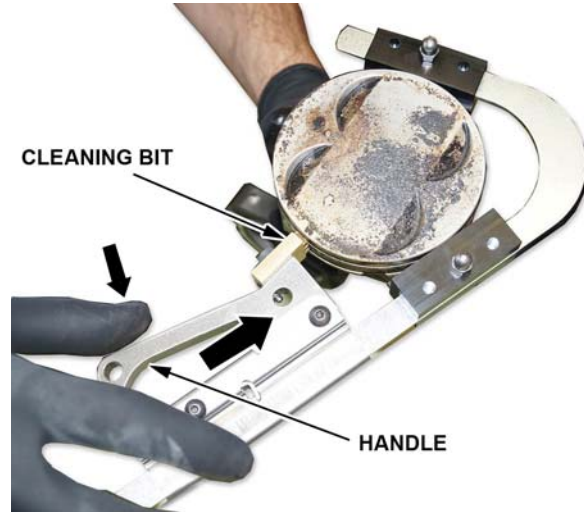
4. Press the handle on the piston ring groove cleaner tool and slide the cleaning bit onto the appropriate piston ring grooves.

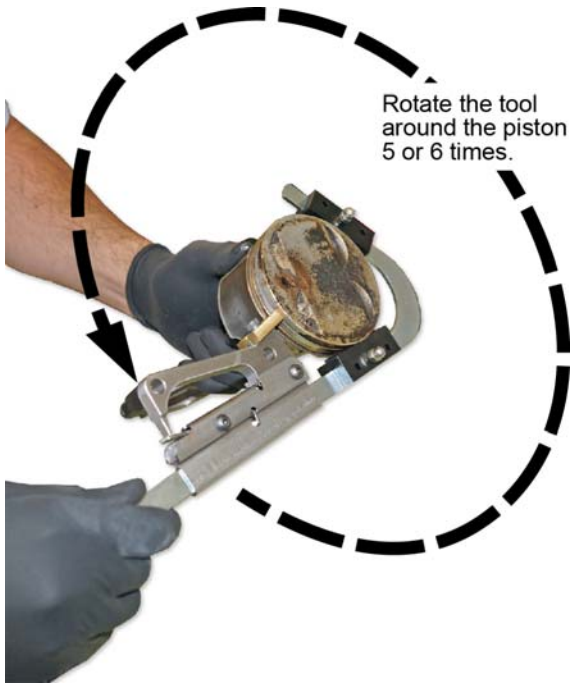
6. Hold the piston steady and rotate the tool counter-clockwise five to six times to remove any carbon deposits in the piston ring grooves. **Do not** rotate the tool clockwise.

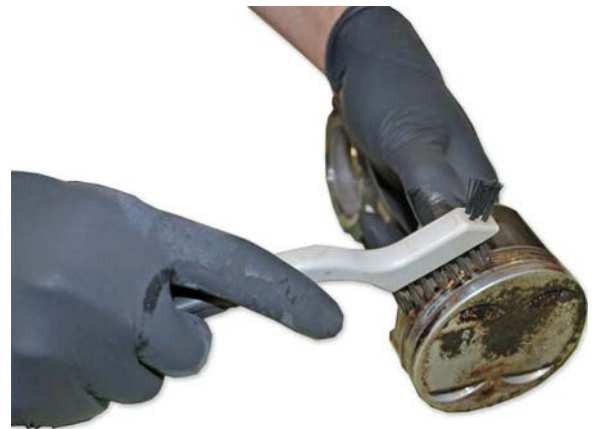
7. Remove the piston groove cleaning tool and clean off the carbon from the tool bit.

8. Finish cleaning the piston with throttle plate cleaner and the nylon brush. **Do not** use a steel wire brush.
