Bulletin No.: PI1135

Service Bulletin

Subject: Service Rear Axle Message Displayed on Drivers Information Center (DIC), DTC C0407 Set

Models: 2014 Chevrolet Corvette Equipped with Electronic Limited Slip Differential (ELSD)
Condition/Concern

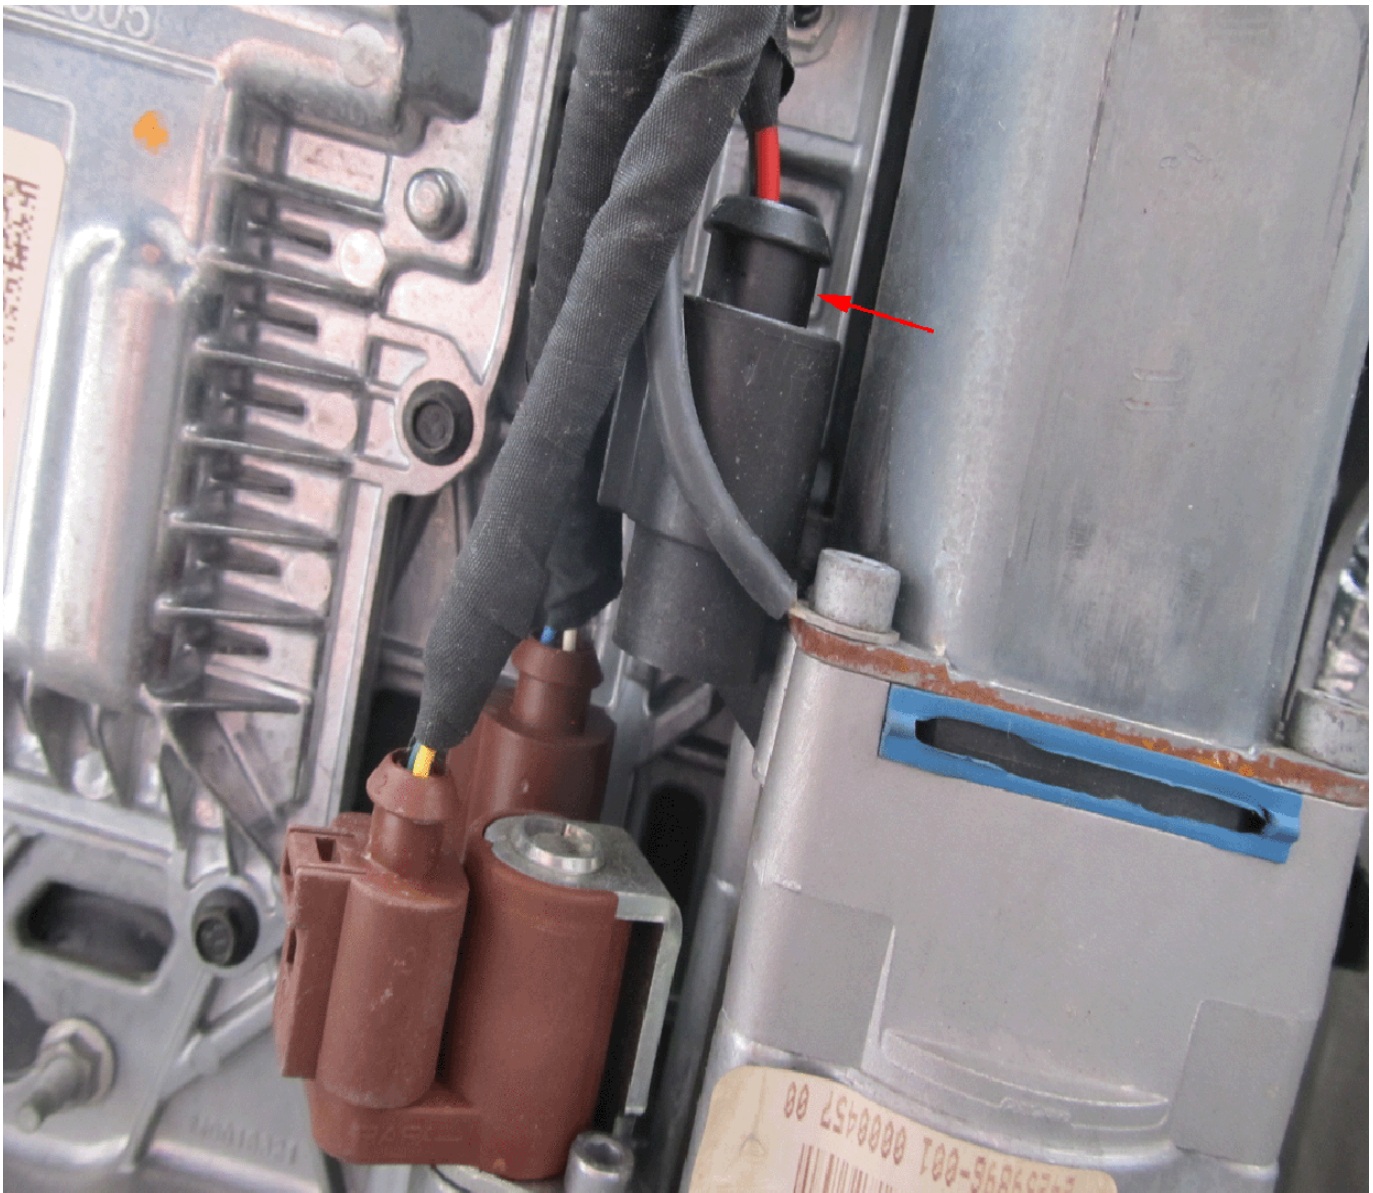
3665321

Technicians may find DTC C0407 set due to the connector on the pump motor, located behind the lower edge of the rear fascia, not properly seated as shown in the illustration above.

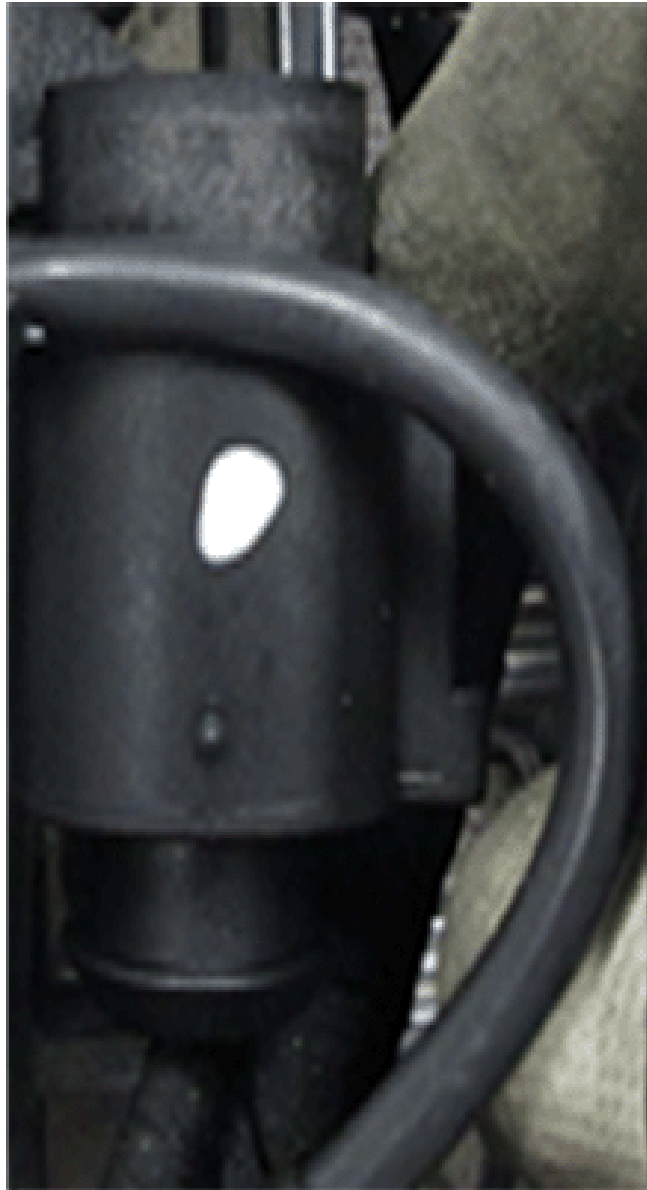
3665323

- Inspect the connector to see if a white dot is present as shown in the illustration above. If a white dot is on the connector, follow SI for further diagnostic procedures. The connector has already been inspected at the plant.
- If the connector doesn't have a white dot, inspect and fully re-seat if loose, then clear any DTCs set or in history.
