Service Bulletin

Bulletin No.: 08-08-110-001G

Subject: Folding Top Headliner Wear (Remove Sharp Edges, Replace Pins/Retainers and Headliner)

Models: 2005-2013 Chevrolet Corvette Convertible

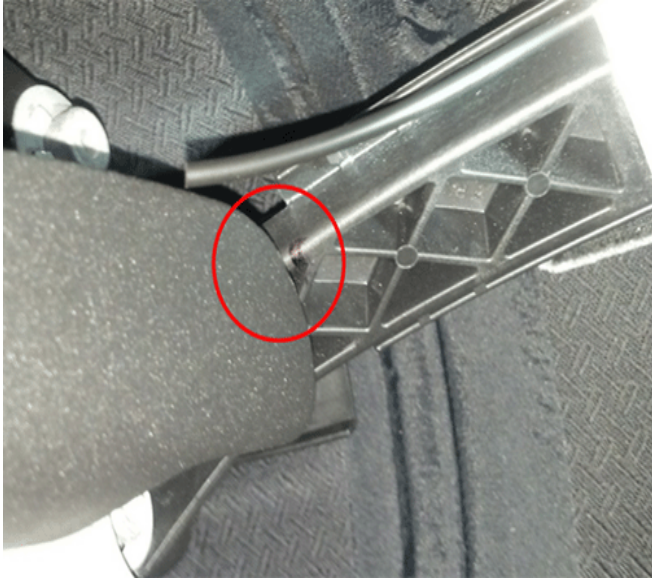
3446273

In less common cases, where the damage may be specific to the left or right upper B-pillar area, the cause may be interference of the upper side roof rail to the #3 bow plastic insert. This interference is shown circled in the graphic above.

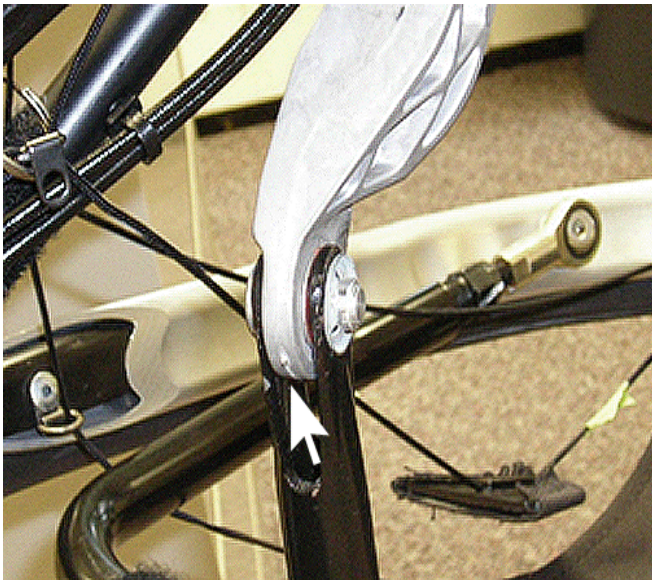
2374446

Note: The graphic above shows an example of the second design side rail link, which has a burr (at white arrow) on the metal casting. Removing/smoothing out this burr will help protect the headliner from damage during top cycling.

Remove the headliner and replace the four aluminum pins and retainers. There are two pins and two retainers per side. Also check the convertible top linkage for sharp edges. Sand down all sharp edges and paint as necessary. Replace the headliner following the procedure listed below:
