Subject Spots in Window Glass		Market USA
Service Category Vehicle Exterior	Section Window/Glass	
Applicability All Models

Subject Spots in Window Glass	Market USA
Applicability All Models

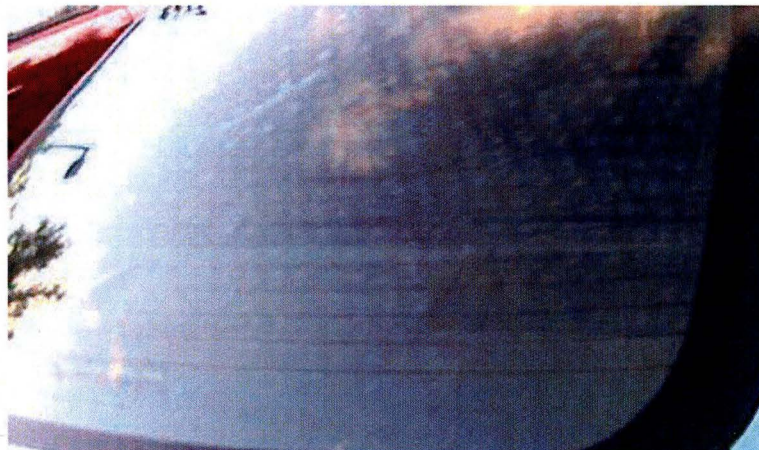
The appearance of spots in tempered glass (when viewed at certain angles) is the result of the heat treating and quick quenching process during manufacturing.

- The condition appears as faint shadowy spots and or lines in the glass.
- They become visible in the transmission and in reflection of light off the glass surface.
- The condition is more visible when viewed from an angle, rather than directly facing the glass.
- When polarized sunglasses are worn, they can dramatically enhance the appearance of the spots and lines.
- The spots seem to be easier to see on a sunny day when the light comes from a blue sky or is reflected from clouds. They are less visible on a gray, cloudy day.
- Tempered or heat treated glass can be found on the vehicle side and the back glass areas.
- An example of how the phenomenon appears is shown below.

This is a normal phenomenon for tempered glass and glass exhibiting the condition outlined above should not be replaced.
