**Touch Screen Inoperative with Display Audio**

12-14MY Multiple Models w/Display Audio

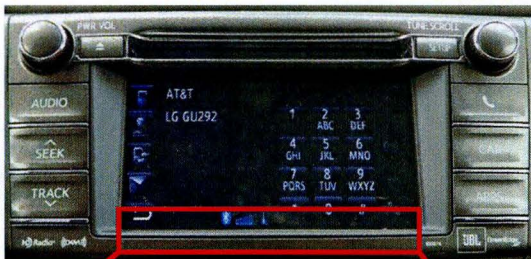
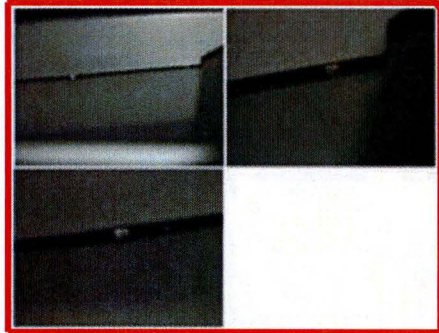
This condition may be caused by foreign object or debris stuck between the display audio screen and the faceplate. If you see any foreign object or debris (refer to the pictures below), please use paper/card with thickness less than 0.1mm (e.g. business card) to remove it.

- Radio screen/button layout can be different by model.
- Do not blow air onto the faceplate to remove the debris, compressed air sprayed on the display can cause moisture inside the radio assembly.
