| <b>Brand</b> | Bentley |

Transaction No.: 2035067/1

Over check for clip removal cars having had E788 applied between 25th July and 16th August 2013

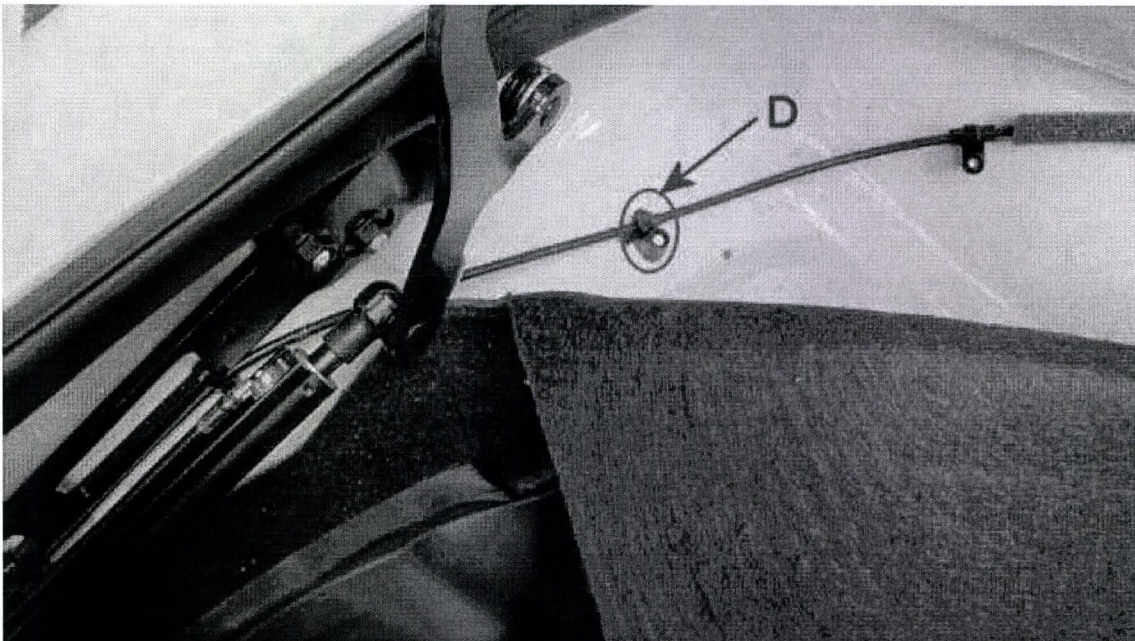
Due to an omission in the text of campaign document E788, *Convertible roof – revised clip arrangement – C flap Bowden cable (SC13/12) version 1*, one clip on each Bowden cable (two clips in total) that should have been deleted may still be present. Each specific VIN requiring this over check is listed in this document

Therefore at the next scheduled dealer visits check for the presence and if necessary remove the two relevant clips (D) detailed below. Version two of campaign document E788, published on the 16<sup>th</sup> August 2013, incorporates the detail for removal of these clips

Temporarily reposition the corner of the hood stowage compartment carpet to view point D, if present discard the clip securing the Bowden cable at point D perform this operation on both sides of the car. Reposition the corner of the hood stowage compartment carpet.
