# Service Bulletin

Bulletin No.: PIP5133

**Subject:** 2010 through 2013 6.6L Duramax Fuel Injection Pump Part Restriction

**Models:** 2010 - 2013 Chevrolet Express, Silverado  
2010 - 2013 GMC Savana, Sierra  
Equipped with the 6.6L Duramax Diesel Engine RPO codes LGH and LML

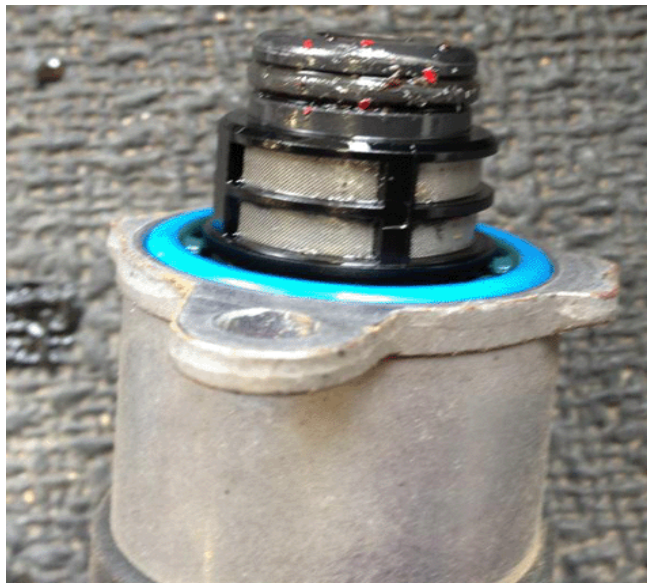
3541170

Questionable Fuel Pressure Regulator 1 (View A)

If the debris on the Fuel Pressure Regulator compares closest with Group B; more diagnosis is needed. Remove the Fuel Rail Pressure Sensor and/or Fuel Pressure Regulator 2 (Pressure Relief Valve) for inspection.

- If the same debris is found and the debris is magnetic, the Fuel Injection Pump is experiencing the condition described in the latest version of PIP4949. Call PQC to request the Fuel Injection Pump.
- If there is no debris found or non-magnetic debris found, the Fuel Injection Pump is not experiencing the condition described in the latest version of PIP4949.

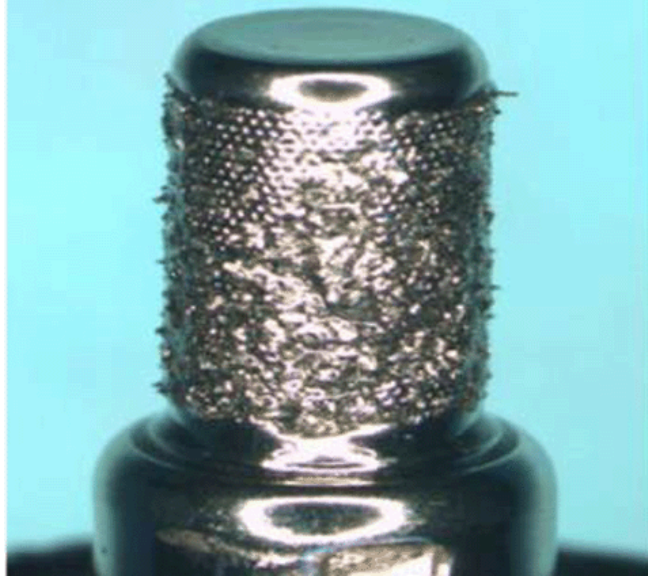
3541168

## Contaminated Fuel Pressure Regulator 2

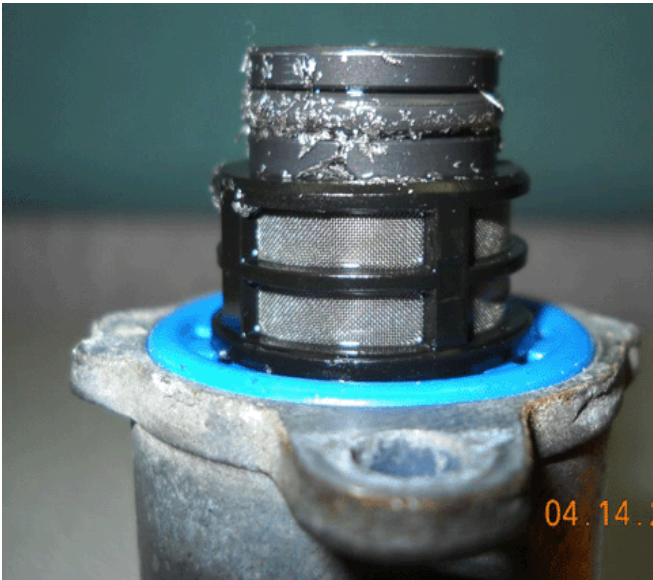
3541164

Contaminated Fuel Pressure Regulator 1 (View B)

If the debris on the Fuel Pressure Regulator compares closest with Group C and the debris is magnetic; the Fuel Injection Pump is experiencing the condition described in the latest version of PIP4949. Call the PQC to request the Fuel Injection Pump.
