Bulletin No.: PIC5887

Subject: Broken Air Suspension Compressor Mounting Bracket Bolts

Models: 2013-2014 Cadillac XTS

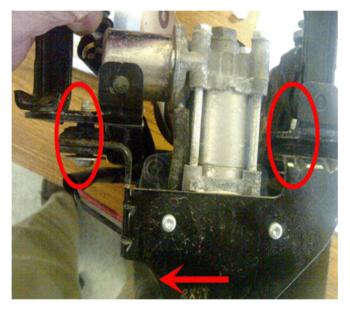
3541926

Some technicians may find one or more broken air suspension compressor mounting bracket bolts. See image below for the bolt location.

Note: The Red arrow represents the front of the vehicle.

These bolts are not currently serviced or available separate from the compressor assembly. Engineering is also looking to review these parts as an undisturbed assembly. If a vehicle is found with this condition, please replace the compressor assembly without disturbing the broken bolts as much as possible. The parts will be reviewed by Engineering through the normal warranty parts return process.
