Service Bulletin

Bulletin No.: PIC5874

Subject: Fluttering Rattling or Thumping Type Noise Above 45 MPH

Models: 2011 - 2014 Chevrolet Cruze
2012 -2014 Buick Verano

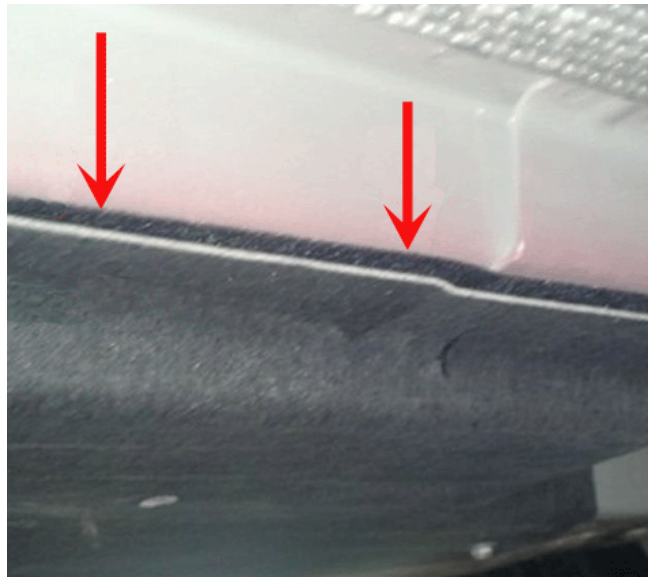
3460857

A customer may indicate there is a flutter or thumping type noise from the side or underneath the vehicle at speeds 45 mph and above.

Check the air deflectors mounted on either side under the vehicle. Make sure that all fasteners are in place and secure. Replace fasteners as needed.

If all fasteners are secure, it may be necessary to apply felt to the underbody above the the inside edge of each air deflector (between each fastener location) to eliminate this noise.

Note: If the customer makes frequent trips on a gravel road, it may be necessary to remove the deflectors, clean off debris, and reinstall.
