Reference SSM67957

Models F-TYPE / X152

Title Clarification of Correct Rear Damper Module Build Condition

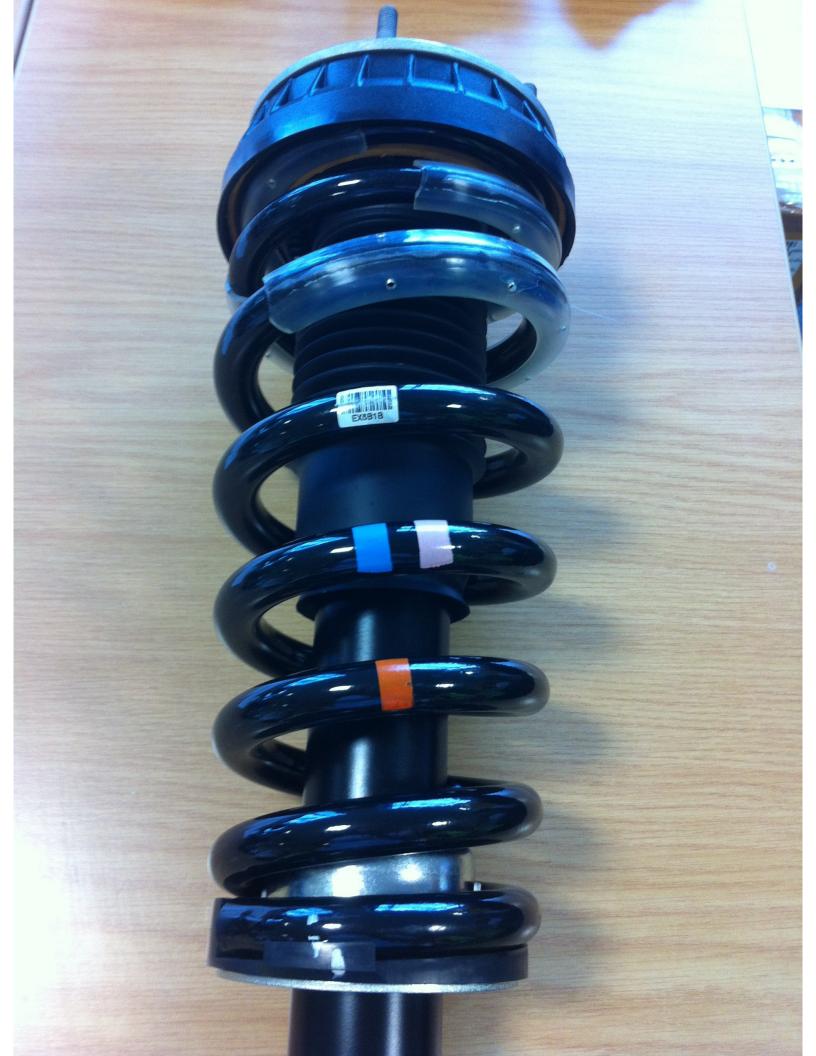
Action: If the bottom Paint mark on the Spring is White,

then there should be a Spring packer/Spacer fitted.

Content If the bottom Paint mark on the Spring is Orange, then

there should not be a Spring packer / Spacer fitted.

Refer to photo for example of paint marking.
