Service Bulletin

Bulletin No.: PIC5831

Subject: Diagnostic Tip - Convertible Roof Rivet Replacement

Models: 2011 - 2014 Chevrolet Camaro Convertible

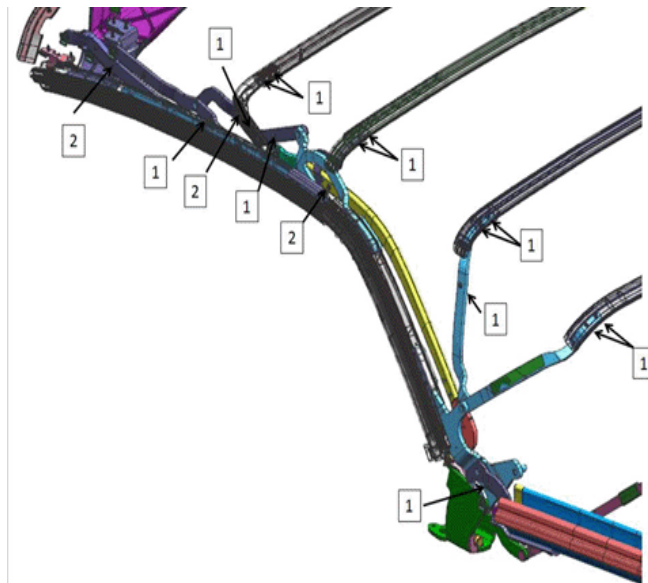
3346640

Using the illustration will aid in the dealer obtaining the correct rivet for the repair being performed.

Callout #1 represents Part Number 11546538

Callout #2 represents Part Number 11546537

The Electronic Parts Catalog (EPC) may show multiple different rivet sizes and this could create confusion regarding which rivet is needed for which location.
