## SERVICE BULLETIN

**APPLICABILITY:** 2014MY Forester Models

**NUMBER:** 12-151-13R

**SUBJECT:** Increase to Detent Force of Front Door Checker Mechanism

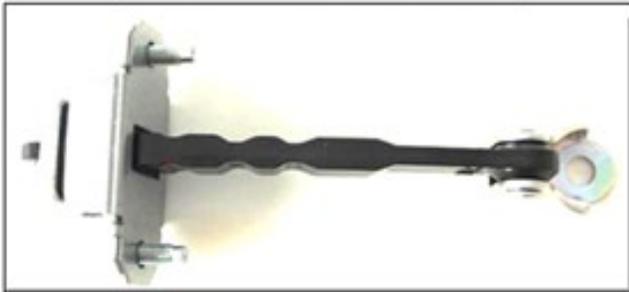
**New part: 61124SG003**

**Three detent positions**

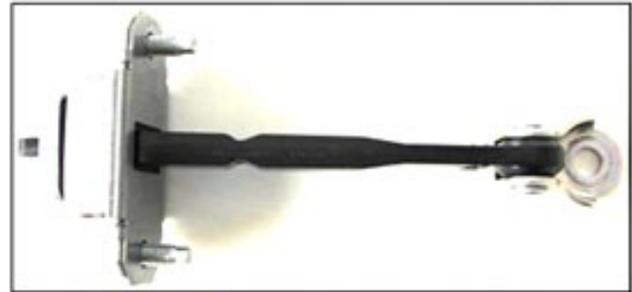
**Old part: 61124SG002, 000**

**One detent position**
