Recall Bulletin

F/CMVSS NONCOMPLIANCE RECALL

SUBJECT: Air Bag Warning Label - Loss of Adhesion

MODELS: 2013-2014 Chevrolet Camaro Coupe

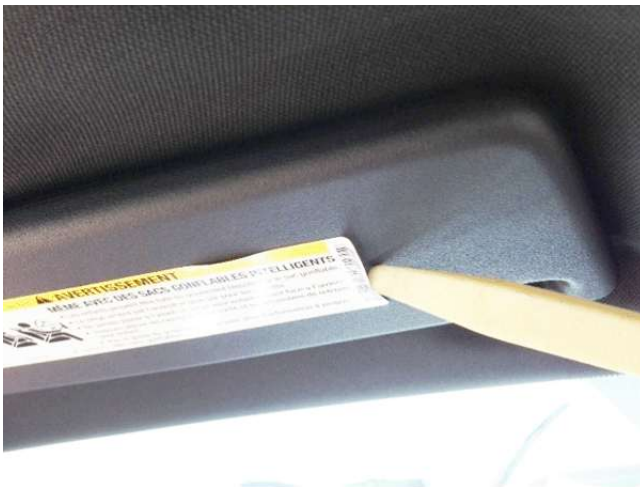
3620946

Note: Certain 2013-2014 Chevrolet Camaro Coupe vehicles were built with one or two sunshades that may have air bag warning labels that have started to peel off, or have fallen off completely.

1. Inspect the air bag warning label on each of the sunshades for proper adhesion.
 - If the air bag warning label is properly attached to the sunshade, no further action is required.
 - If the air bag warning label has fallen off or has started to peel off, replace the sunshade. Proceed to step 2.
2. Remove the sunshade from the vehicle. Refer to *Sunshade Replacement (Coupe)* in SI.

3. Install a new sunshade. Refer to *Sunshade Replacement (Coupe)* in SI.
