# Service Bulletin

Bulletin No.: PI0631G

**Subject:** Malfunction Indicator Lamp (MIL) On, Various DTCs Set, IPC Inoperative, Display and/or BCM Fuse Blown

**Models:** 2012-2013 Chevrolet Impala  
Built Prior to VIN Breakpoint D1207466

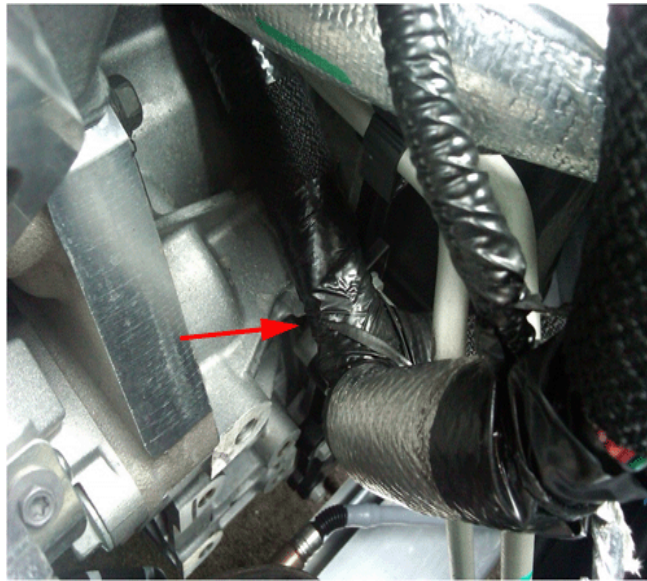
2743910

Technicians should inspect the engine harness for any damaged wires at the right front and the rear of the wire harness.
