Service Bulletin

Bulletin No.: PI0887B

Subject: Pulsating/Rotational Noise from Right Rear of Vehicle on Brake Apply

Models: 2012-2013 Chevrolet Cruze
Equipped with Drum Brake (RPO J93)
Vehicles Built Prior to VIN Breakpoint D7161078

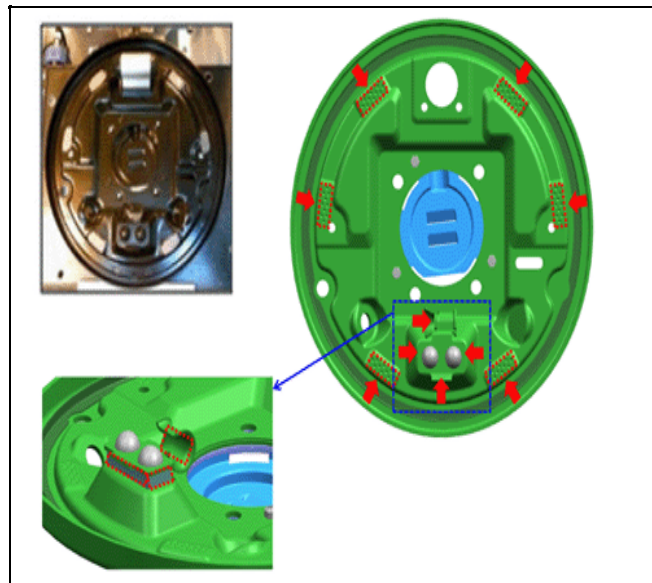
2965726

Some customers may comment about a pulsating/rotational noise coming from the right rear of the vehicle during brake apply.

This noise may be caused by an interaction between the brake drum and brake shoe.

The right rear brake drum and rear brake shoes need to be replaced including applying a high temperature grease, GM P/N 12345996 (in Canada, 10953501), or equivalent, on all the locations of the backing plate as shown in the illustration above.

Note: DO NOT replace the left rear drum as this noise condition only pertains to the right side.
