Service Bulletin

Bulletin No.: PI0948

Subject: Driver or Passenger Power Seat Back Recliner Stuck and/or Will Not Recline

Models: 2013 Cadillac ATS

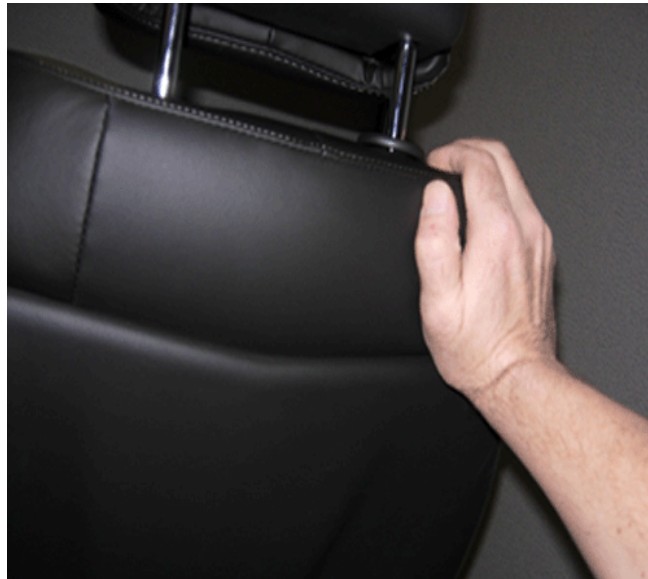
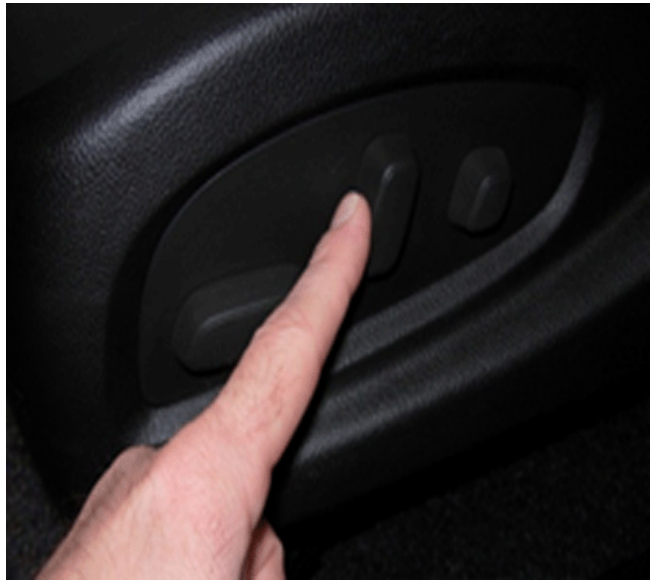
3356939

1. Push forward against the rear inboard top surface of the seat back while pushing the recliner switch rearward as shown in the illustrations above.

Note: Once the seat back starts to move rearward, stop pushing on the rear inboard top surface.

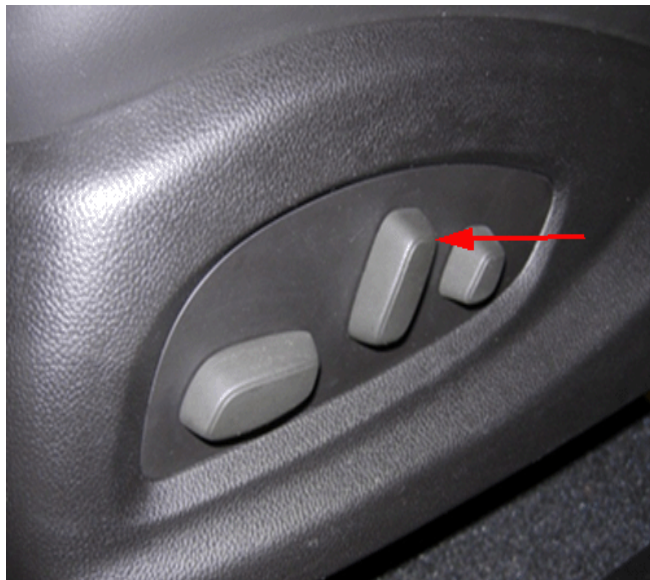
3356947

2. Using the power recliner switch, move the seat back forward against the full forward travel stop as shown in the illustration above.

Note: Continue activating the forward switch for 2-4 seconds after the seat back stops moving.

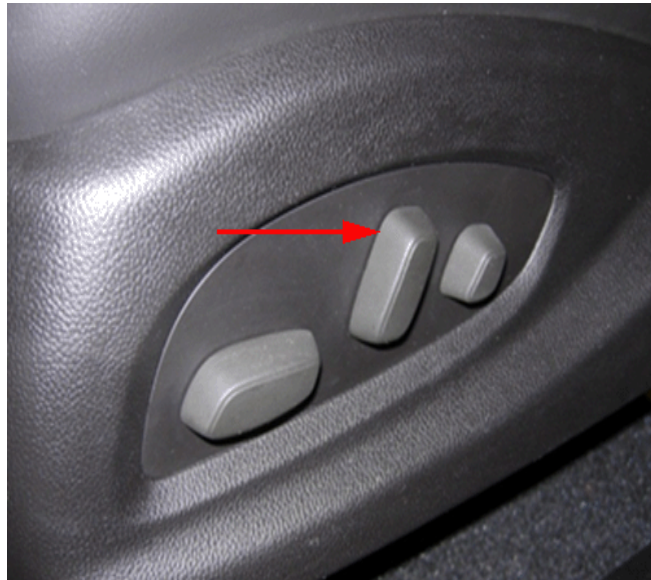
3356952

3. Using the power recliner switch, move the seat back rearward off the full forward stop for a few degrees as shown in the illustration above.
4. Repeat steps 2 and 3 for 5 cycles.
