Service Bulletin

Bulletin No.: PIC5779A

Subject: Information on Preparation / Washing to Avoid Damaging Bright Aluminum Moldings

Models: 2011 - 2013 Chevrolet Cruze
2011 - 2013 Buick Regal
2013 Cadillac ATS, XTS

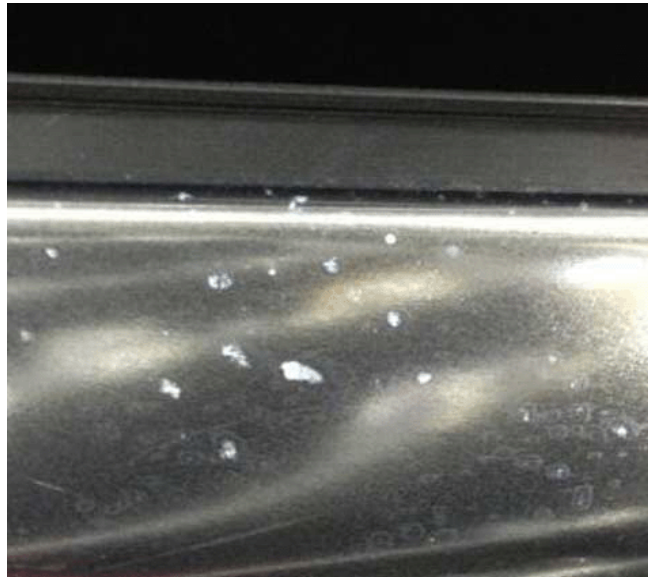
3163627

In order to avoid damage that may not be covered by your warranty, it is recommended that a non-alkaline solution be used for preparation & washing of the Bright Aluminum Moldings.

If a cleaning solution greater than 11.0 pH is used, the following procedure must be used:

- Prewash the vehicle to bring moldings to room temperature.
- Apply cleaning solution out of the sunlight at room temperature.
- Rinse moldings with clean water within 5 minutes of application of cleaning solution.
