# Service Bulletin

Bulletin No.: PI1034

**Subject:** Check Engine Light On with DTC P0442 Set

**Models:** 2014 Chevrolet Impala  
Equipped with 3.6L Engine (RPO LFX)

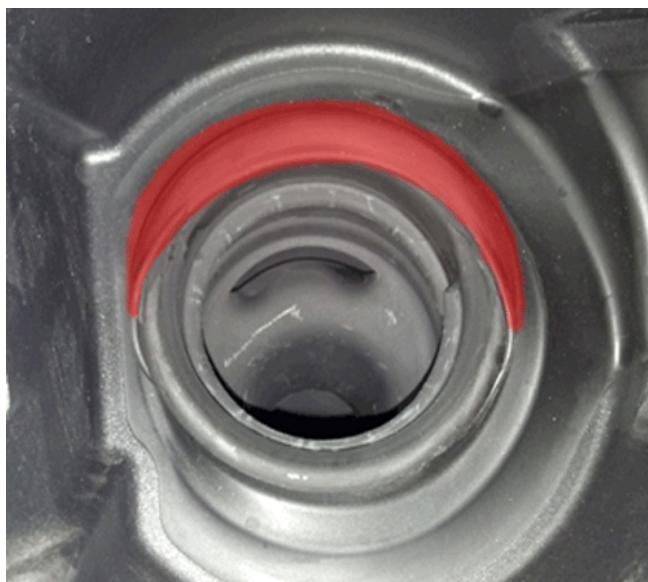
3603856

This condition is due to the seal on the fuel tank filler pipe housing not seated properly during vehicle assembly, causing a small EVAP leak and the seal to overlap the fuel tank filler neck as shown in the illustration above.

Using a trim stick, push the seal over the filler neck and clear the DTC.
