# Service Bulletin

Bulletin No.: PI1076A

**Subject:** Revised Front License Plate Bracket Installation Instructions

**Models:** 2014 Chevrolet Malibu

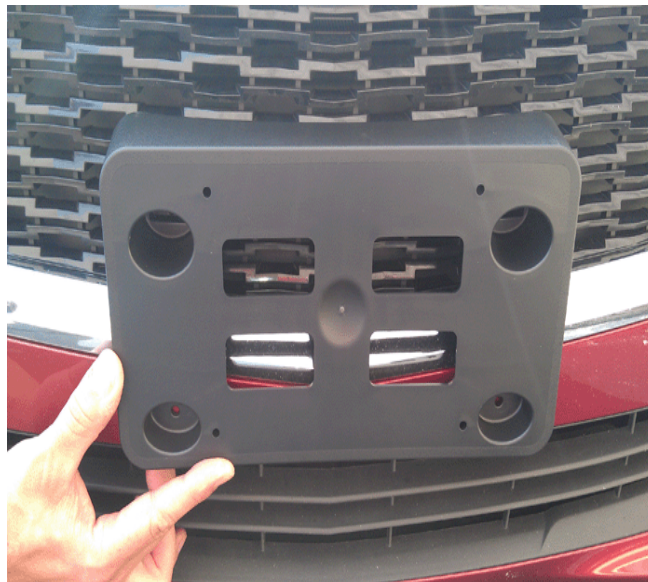
3632266

The front license plate bracket attachment package contains four rivets, and two of those rivets are not long enough to secure the bracket at the upper mounting hole locations.

Obtain the two new longer rivets, GM P/N 11516936, and perform the following:

1. Using a 13/64 in (5 mm) drill bit, drill the two upper bracket mounting holes using the dimples in the grille as a guide.
2. Position the license plate bracket to the grille and install the two P/N 11516936 rivets.
3. Using a 13/64 in (5 mm) drill bit, drill the two lower bracket mounting holes using the holes in the bracket as a guide.
4. Install the two rivets that were included in the license plate attachment package, in the lower bracket mounting holes.
