Service Bulletin

Bulletin No.: PI1139

Subject: Information on Elimination of Side Door Striker Trim Covers

Models: 2014 Chevrolet Corvette
Built On or After November 18, 2013

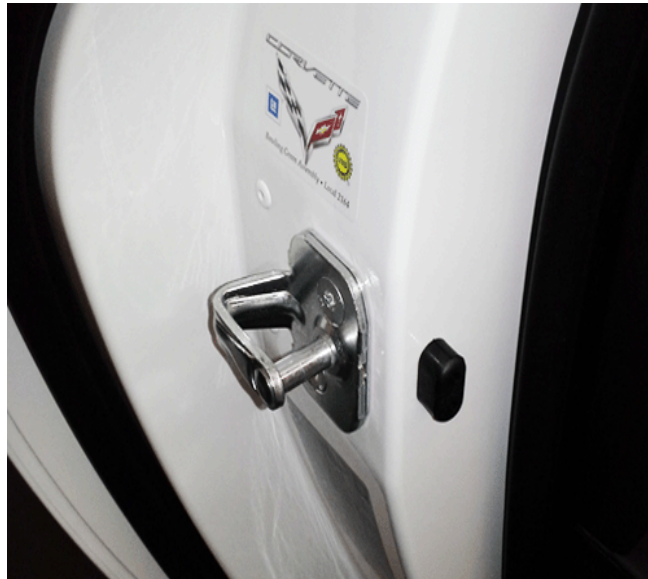
3666454

Some customers or dealers may comment that the vehicle is missing a black plastic trim cover over the door striker.

Effective with build date of November 18, 2013, the door striker trim cover was removed from vehicle production. The current build configuration is shown in the graphic above.

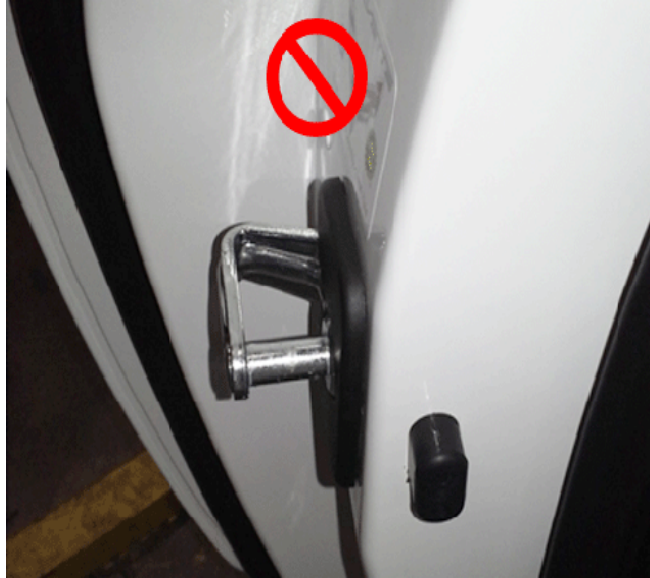
3666460

Due to body variation, the Bowling Green assembly plant may add striker shims, therefore the trim cover will no longer sit flush against the door.

There is no requirement for the cover and cars built without the cover should not have one added.
