Reference	SSM66537
Models	F-TYPE / X152
Title	Rear Storage Box Door Opens When Locking Vehicle
Category	Body
Last modified	11-Jul-2013 00:00:00
Symptom	107000 Interior Trim
Content	<p><u>Issue:</u> The lockable rear interior storage box (cubby box) door may open when locking the vehicle doors.</p> <p><u>Cause:</u> There are two separate causes depending on the VIN range. Vehicles built up to K03276 could have an issue with the storage box latch. Vehicles from K03277 to K03880 may be having the storage box lid preloaded by the left hand rubber stop for the storage box door.</p> <p><u>Action:</u> For vehicles up to VIN K03276 please submit a Technical Assistance Request for further assistance. For vehicles from VIN K03277 to VIN K03880 remove the rubber stop on the left hand side of the rear storage box and cover the hole with suitable felt tape. See attached picture.</p>

F-Type Rear Storage Box

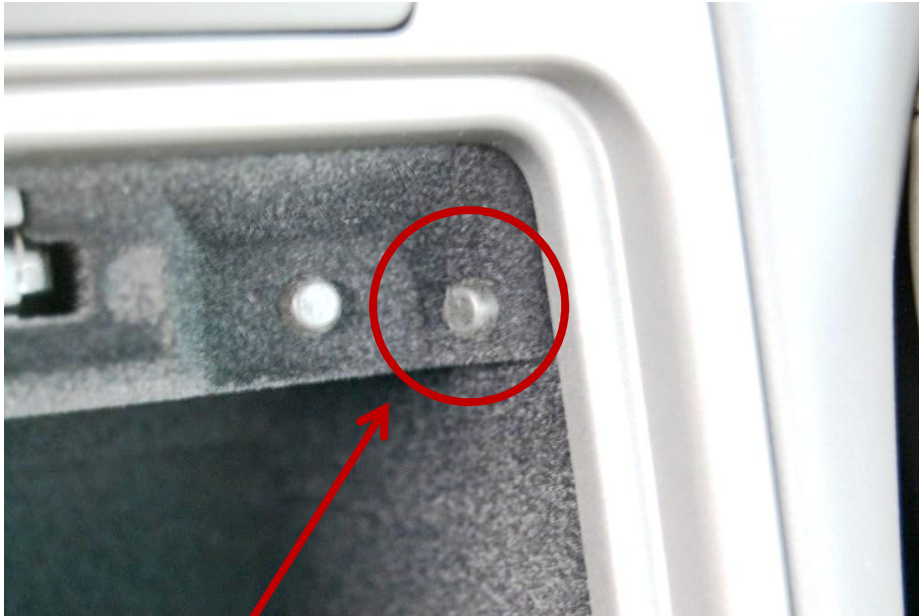
Remove the LH rubber stop from storage box.

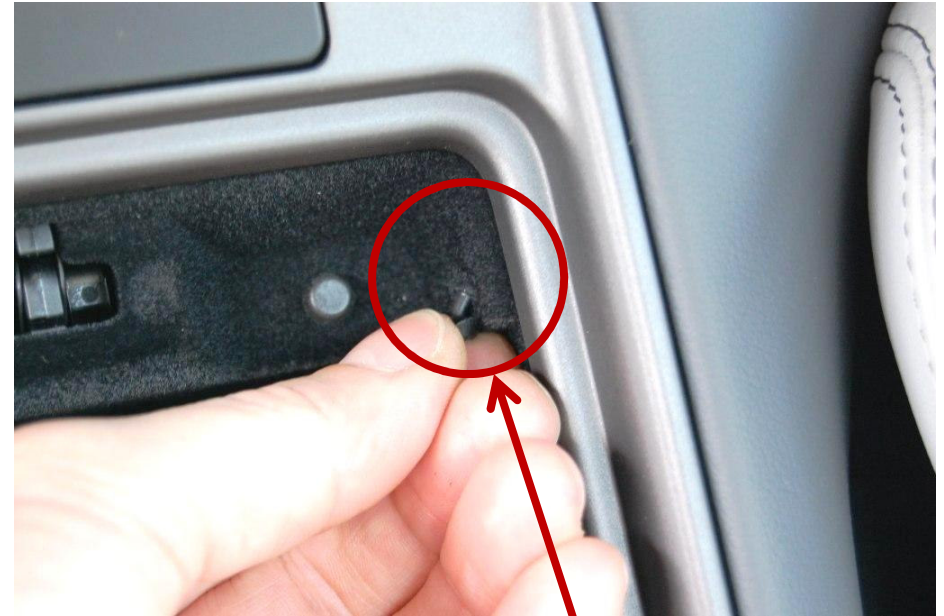
Cover hole with suitable felt tape.
