# Thor Motor Coach Technical Information Bulletin

## TIB # 13-001

Issue: Some Daybreak Class A units need to have brackets installed at the step box.

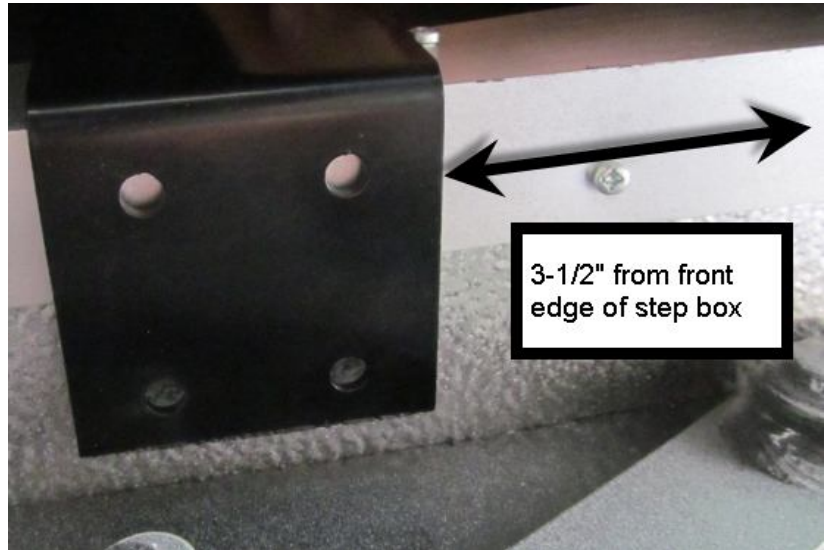
1. Measure 3-1/2" from the front edge of the step box and draw a line.
2. Line the front edge of the new bracket up with this mark.

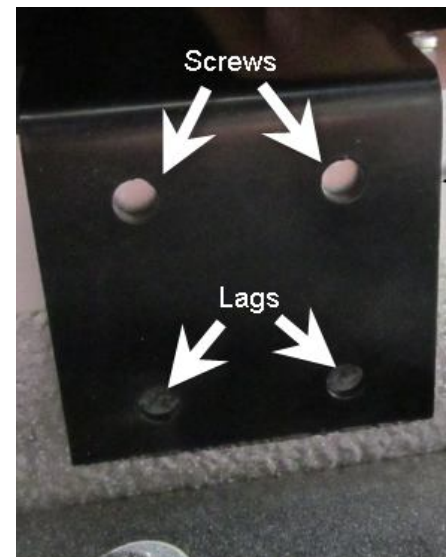
3. Attach the bottom of the bracket to the bottom of the step box using 2 2" self tapping screws and 2 2" lags as illustrated:

**Note:** The self tapping screws go into the holes closest to the step box. The lags go into the holes farthest away from the side of the step box.

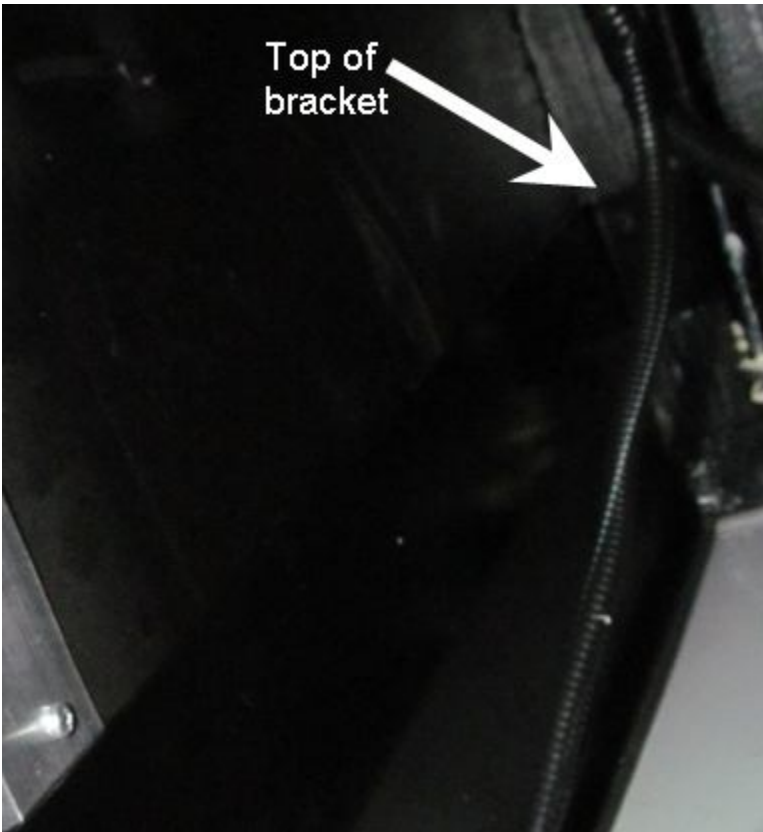
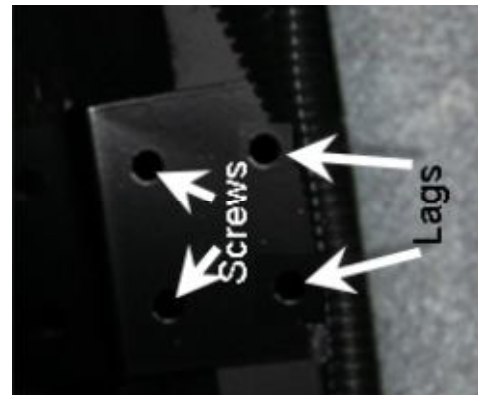
**4a. For Model 34XD and 28PD:**

Secure the top of the bracket to the floor as illustrated below:

**Note:** The self tapping screws go into the holes closest to the step box. The lags go into the holes farthest away from the side of the step box.

**WARNING: BE CAREFUL TO AVOID ANY HOSES AND/OR WIRES WHEN ATTACHING THE TOP OF THE BRACKETS TO THE FLOOR.**

5a. Repeat the procedure for the opposite side of the step box.

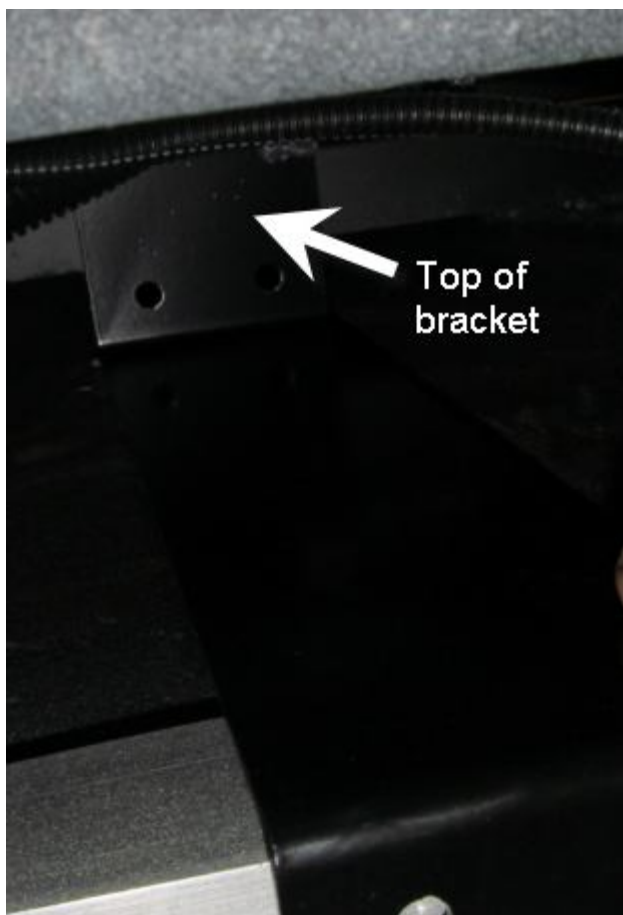
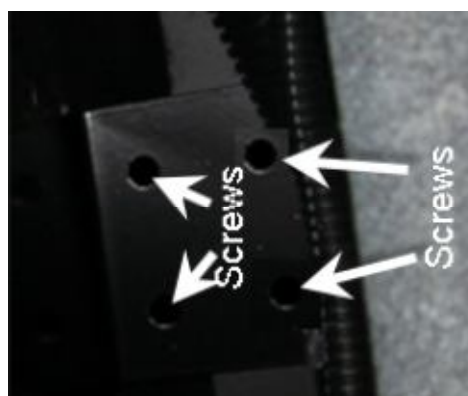
**4b. For Model 32HD:**

Secure the top of the bracket to the truss as illustrated below:

**WARNING: BE CAREFUL TO AVOID ANY HOSES AND/OR WIRES WHEN ATTACHING THE TOP OF THE BRACKETS TO THE TRUSS.**

5b. Repeat the procedure for the opposite side of the step box.

6b. **32HD Only:** Open the luggage doors on either side of the entry door and grind off any screw ends that may be coming through the trunk box.
