Mazda North American Operations Irvine, CA 92618-2922

REFERENCE NO: RF-14-02 DATE: February 11, 2014

SUBJECT: 2014 MAZDA3 AND MAZDA6 - ROOF MOLDING AVAILABILITY

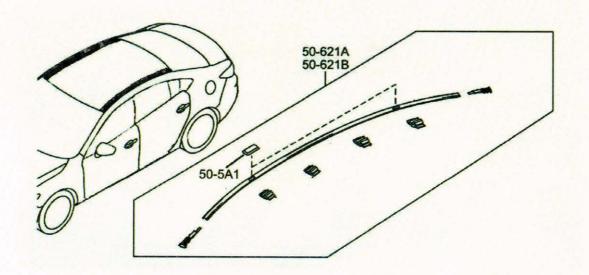
All 2014 MAZDA3s and MAZDA6s are built with roof mouldings that DO NOT HAVE CAPS (that allow fitment of a roof rack), but replacement moldings have caps. If the molding is replaced on one side of a vehicle (and no roof rack is used), it may be necessary to replace the molding on the other side of the vehicle so both moldings have caps.

W/O CAPS NO LONGER SERVICED (USED IN PRODUCTION)	WITH CAPS SERVICE PARTS (NOT USED IN PRODUCTION)
2014 MAZDA3 4-DOOR	<b>R</b> 50-621A	NONE	BHY1-50-9H0
	<b>L</b> 50-621B	NONE	BHY1-50-9L0
	CAP 50-5A1	NONE	GJ6A-50-5A1
2014 MAZDA3 5-DOOR	R 50-621A	BHS2-50-9H0	BHY2-50-9H0
	<b>L</b> . 50-621B	BHS2-50-9L0	BHY2-50-9H0
	CAP 50-5A1	NONE	GJ6A-50-5A1
2014 MAZDA6	<b>R</b> 50-621A	GHK1-50-9H0	GHY1-50-9H0
	L 50-621B	GHK1-50-9L0	GHY1-50-9H0
	CAP 50-5A1	NONE	GJ6A-50-5A1
