<b>Reference</b>	SSM72120
<b>Models</b>	LR2 / L359
<b>Title</b>	Freelander key case bulging.
<b>Category</b>	Body
<b>Last modified</b>	17-Dec-2014 00:00:00
<b>Symptom</b>	112000 Latches/Locks & Security
<b>Attachments</b>	Example Freelander key bulging.pdf Freelander key differences.pdf

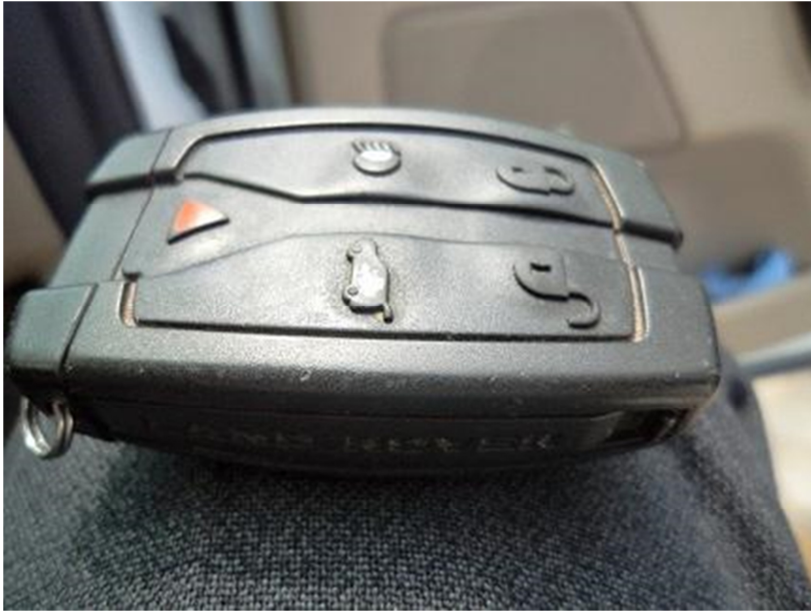
Reports of key case bulging. See attached photo.

Keys were manufactured oversize.

A number of improvements were made to the manufacture of the key when production moved from Cadiz, Spain to Yanfeng, China. See attachment.

EPQR's are only required for issues with keys manufactured in China.  
Please ensure you attach a photo to the EPQR showing this information.  
Please retain the parts for investigation.

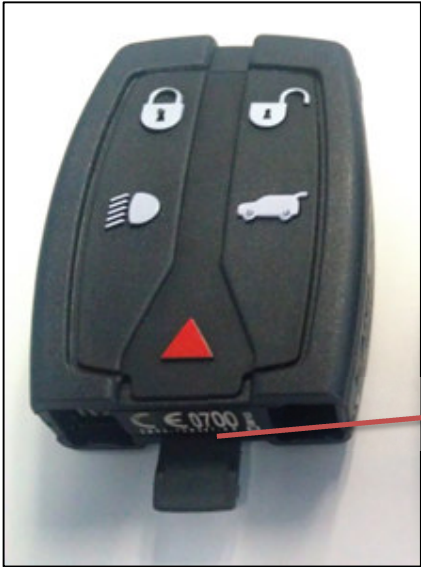
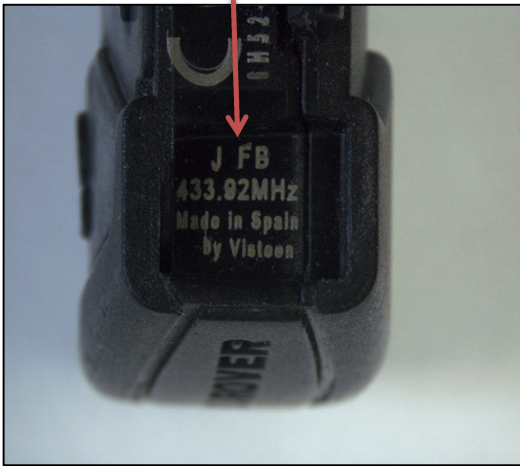
Cadiz, Spain Key

- The country of Manufacture can be identified by unclipping the emergency key blade.
- With the clip for the emergency key blade at the bottom view the block of text to the left of the CE mark
- Keys from Cadiz, Spain have 'Made in Spain'
- Key from Yanfeng China have 'Made in China'
