| REFERENCE: | Nova Bus Manuals |
| SECTION: | 11 Fuel tank |

| SUBJECT: | 60 FT vehicle metallic fuel tank |
| JUSTIFICATION: | Modifications to the fuel tank warranty |

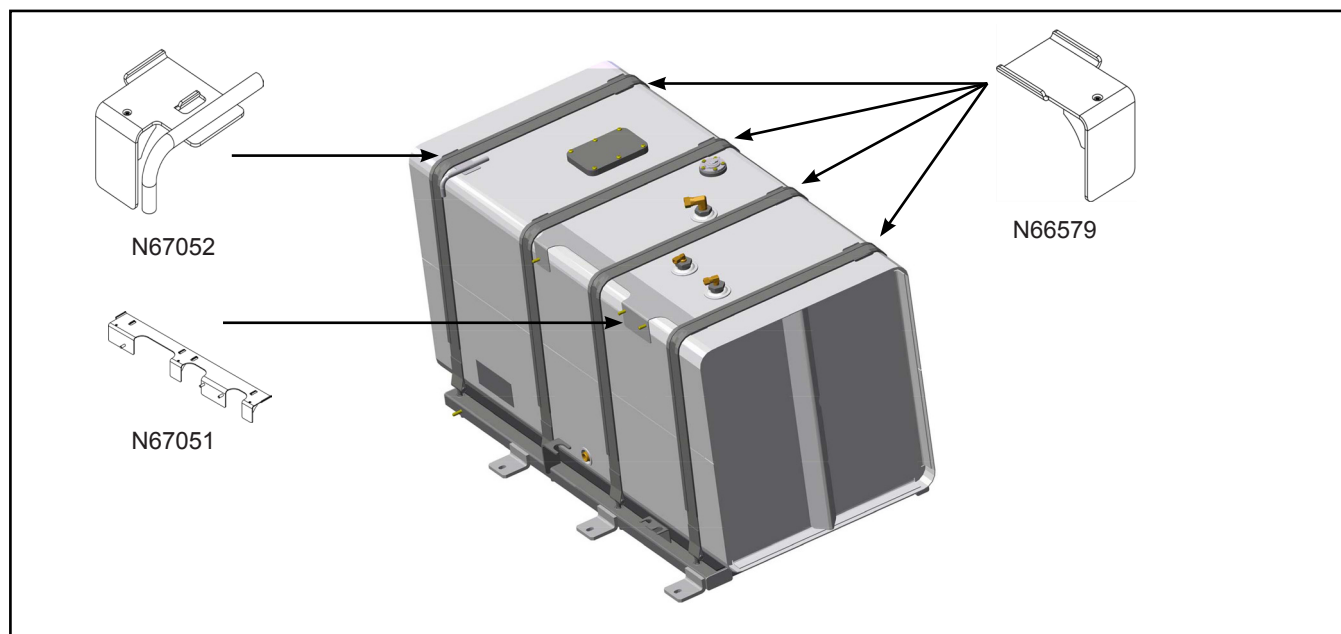
Figure 1 - Fuel Tank

In the case of the fuel tank replacement, N67051 stud plate, the corner supports N67052 and N66579 should be installed under the fuel tank straps. See Figure 1 and the Nova Bus maintenance manual for the replacement procedure.

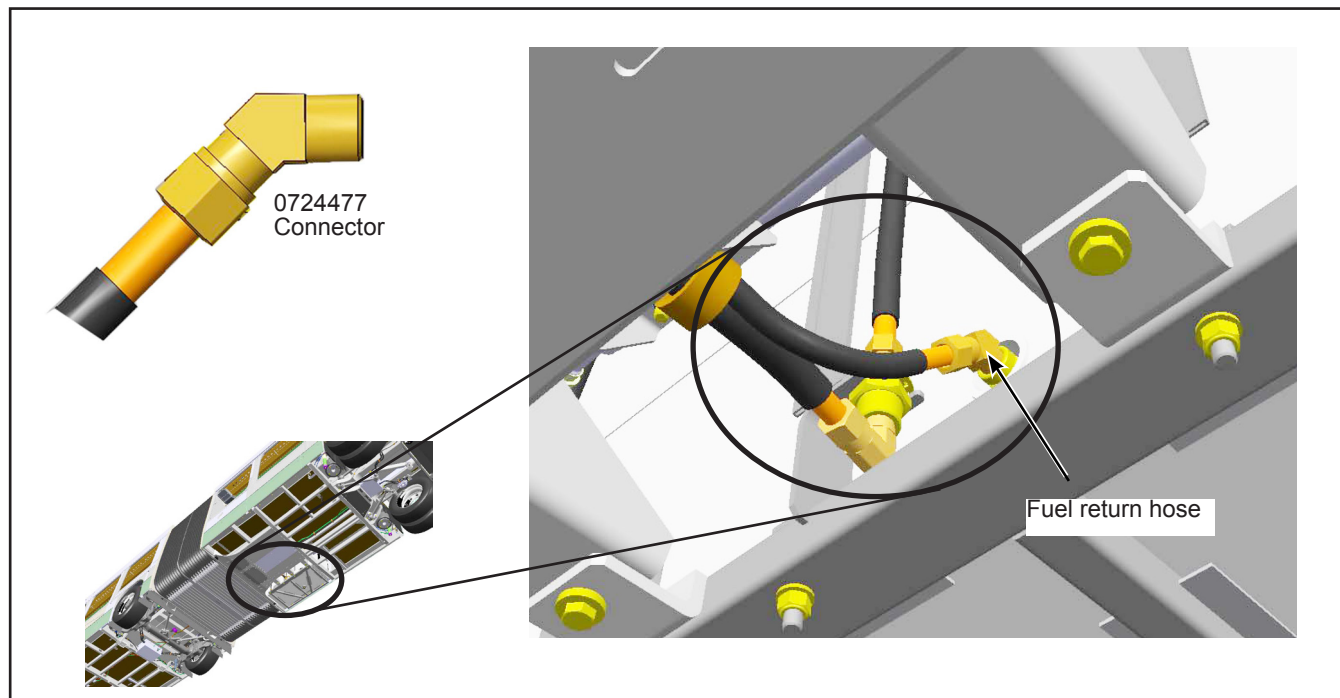
Figure 2 - 0724477 Connector for the Fuel Tank Return Hose

Replace the straight connector with 0724477 angle connector on the fuel tank return hose. See Figure 2.❖
