## sp14-38

### SP14-38 FRONT BUMPER HINGE REPLACEMENT

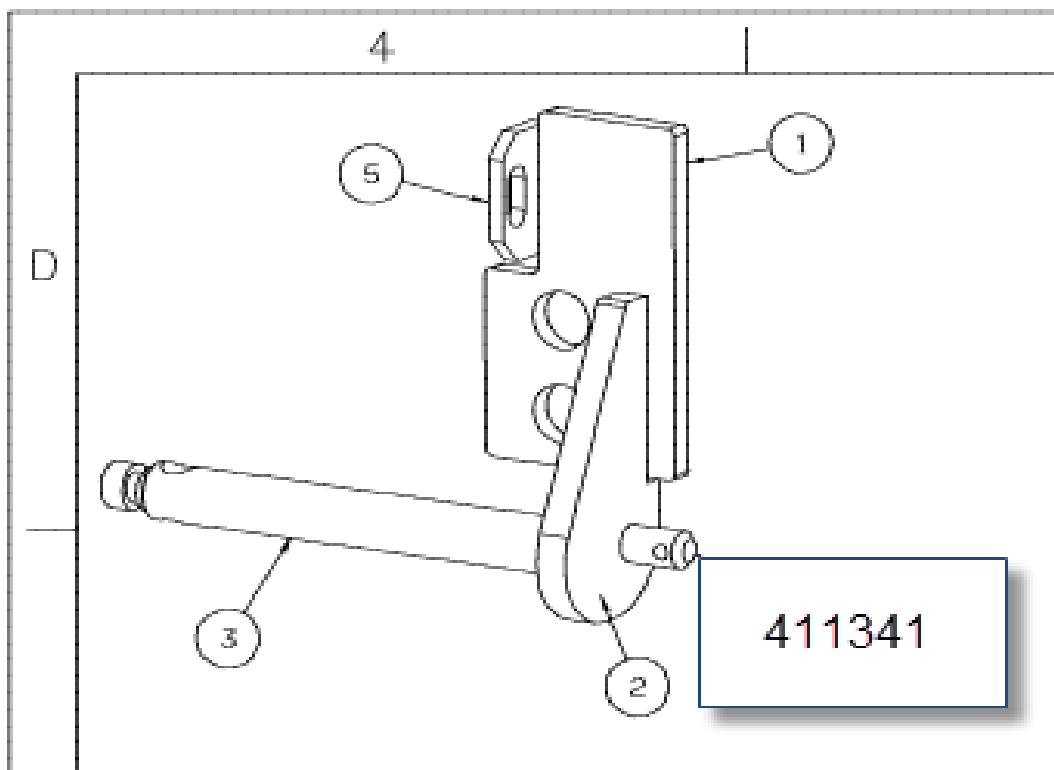
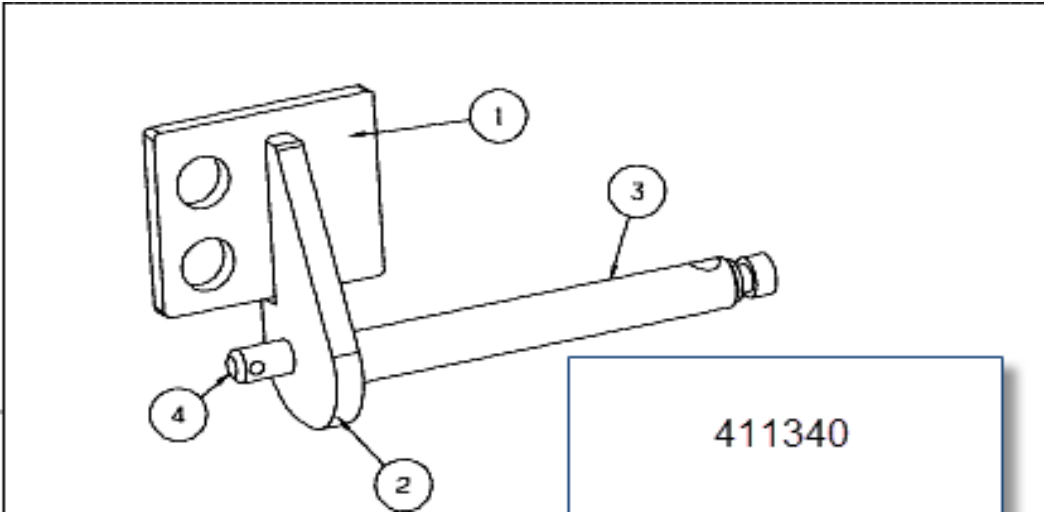
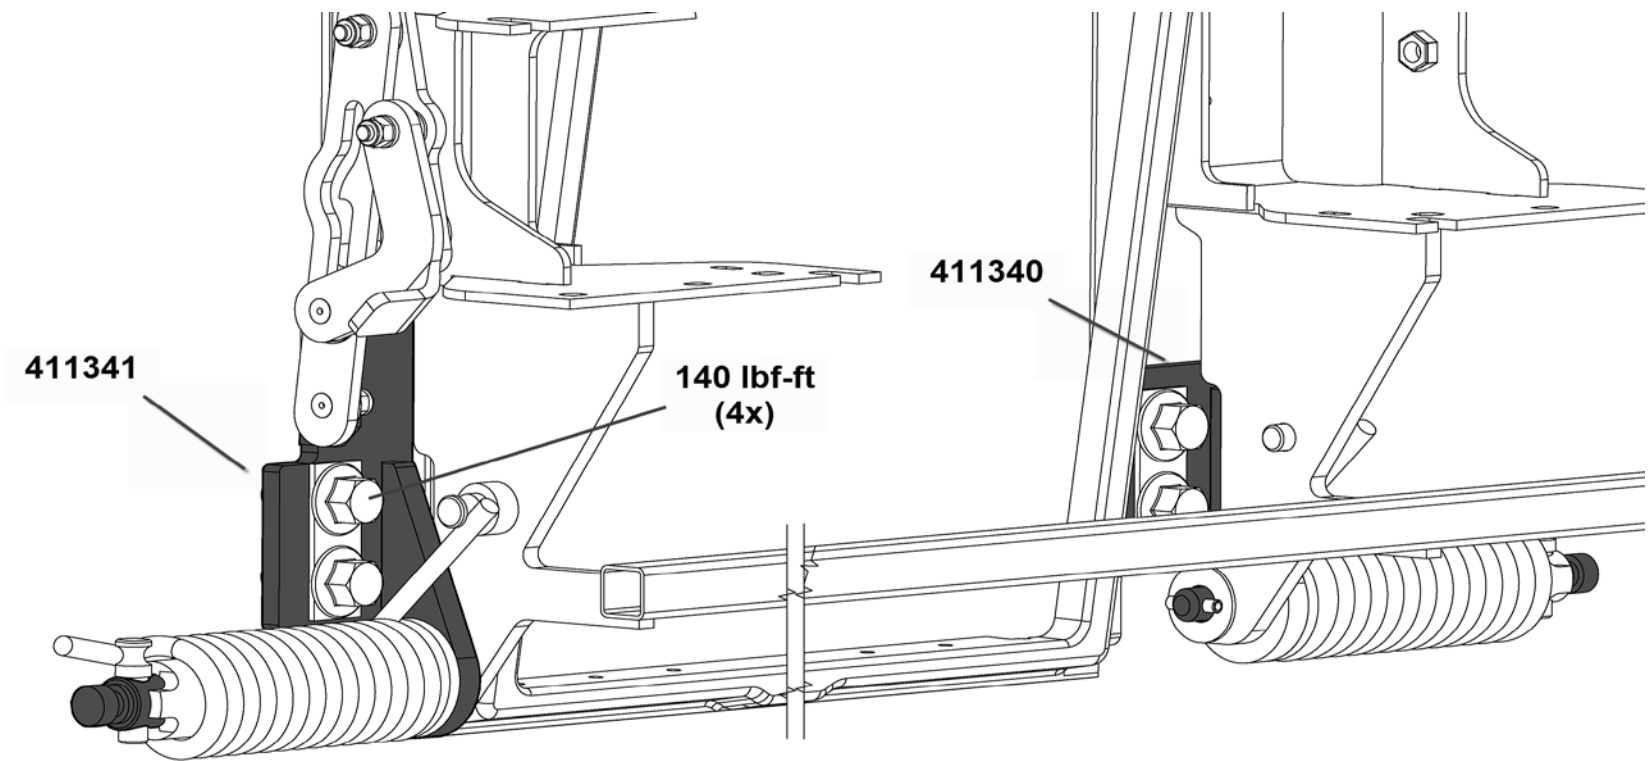
DUE TO INVENTORY SHORTAGE ON PRODUCTION LINE, THE FRONT BUMPER HINGES 411340 & 411341 DO NOT HAVE THE RIGHT PAINT FINISH (POWDER/ ECOAT). PARTS WERE PAINTED IN-HOUSE.

ON FRONT BUMPER

REPLACE LEFT & RIGHT HINGE

411340 ET 411341 QTY 1

READJUST RADAR ACCORDING TO PROCEDURE... in MI14-34 (Maintenance information bulletin)

DISCARD REMOVED PARTS TO RECYCLED METAL
