PREVOST

WARRANTY BULLETIN

WB14-32

DATE :	SEPTEMBER 2014	SECTION: 06- Electrical
EXPIRATION:	SEPTEMBER 2016	
SUBJECT :	MASTER RELAY CORROSION

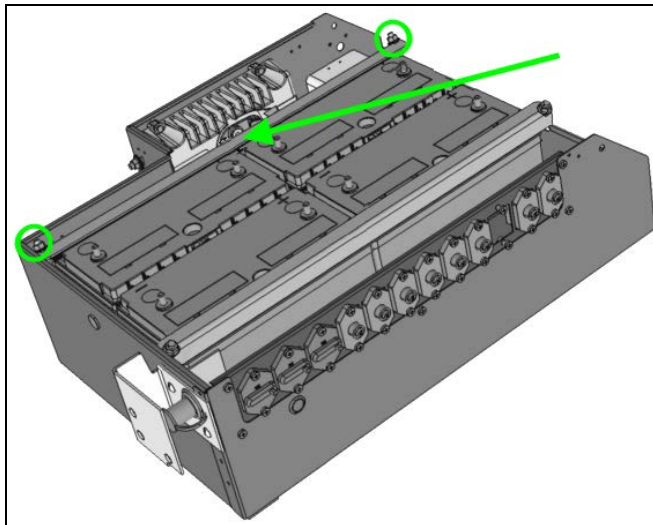
3. Unscrew the two hex nuts that hold the batteries rear retaining angle bar and remove the bar.

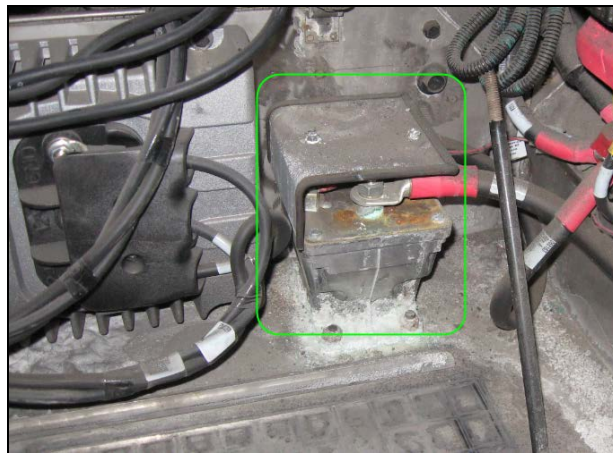
On the vehicles affected by this bulletin, it is possible to observe signs of corrosion at the base of the master relay installed in the vehicle battery box.

5. Locate the master relay fixed at the bottom of the rear corner in the battery box.

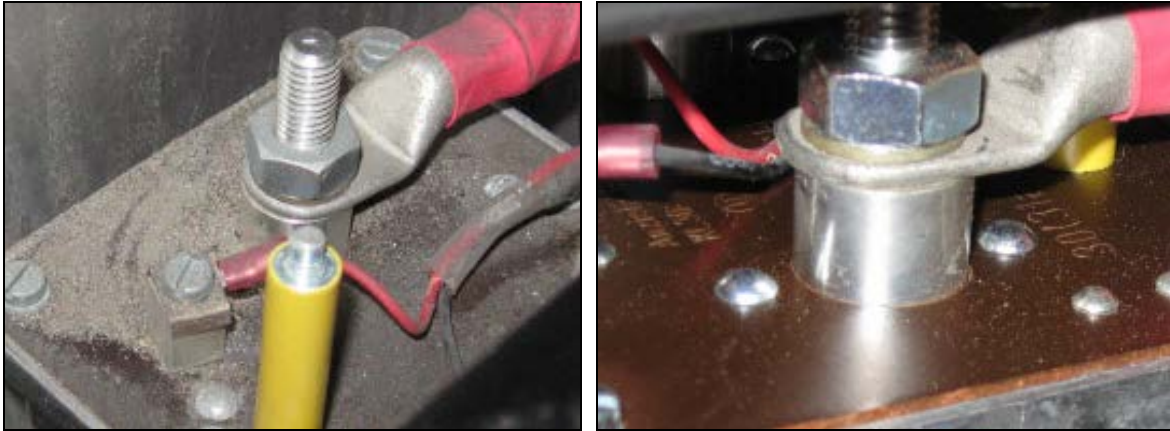
7. Disconnect the two (2) relay power connections hold by hex nuts.

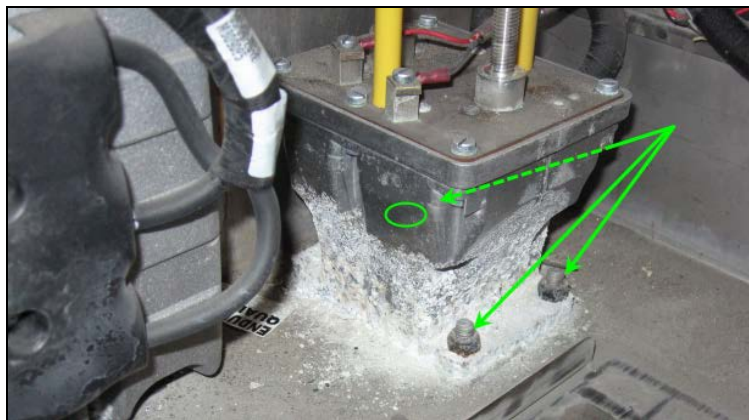
9. Unscrew the three (3) hexagonal bolts that hold the relay to the battery box bottom.

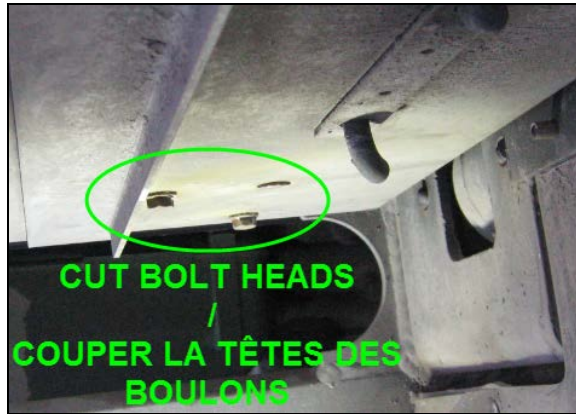
If the hex bolts and nuts are severely attacked by corrosion, it may be necessary to cut the bolts heads from under the vehicle with a rotary cutting tool and suitable eye protection equipment.

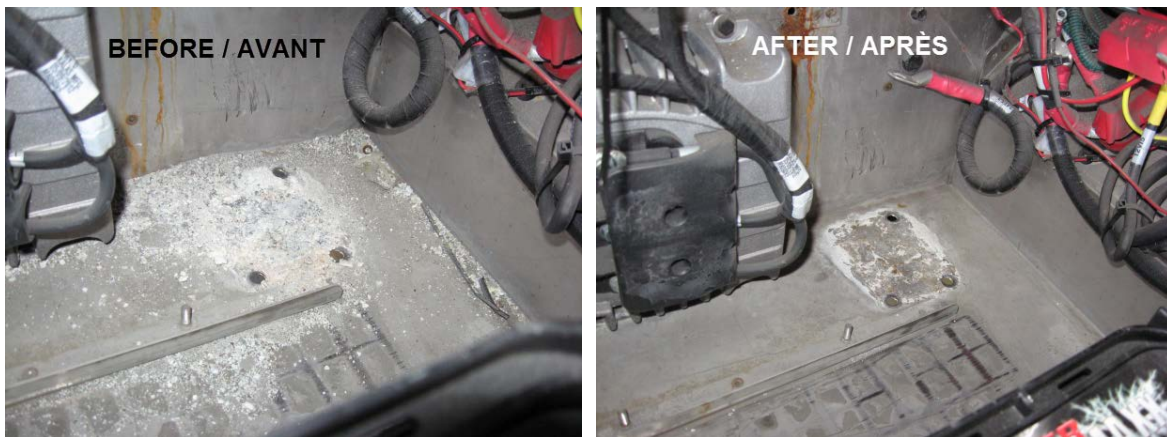
10. Remove the relay from the vehicle.
11. Clean the bottom of the battery box and remove as much of the oxidation residues as possible. Use battery post cleaner as necessary.

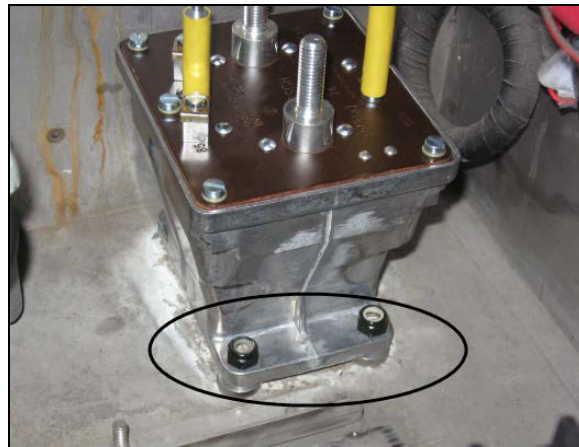
13. Remove the cover from the new relay and install the relay over the stainless washers. Hand tight the three (3) provided hex nuts.

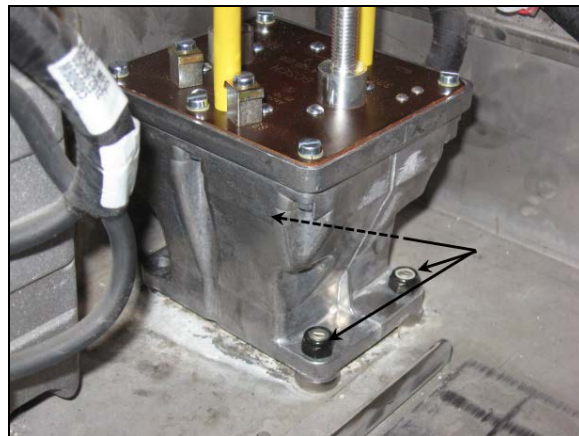
14. Tighten the three (3) hex nuts to 16 ft-lb (22 Nm).

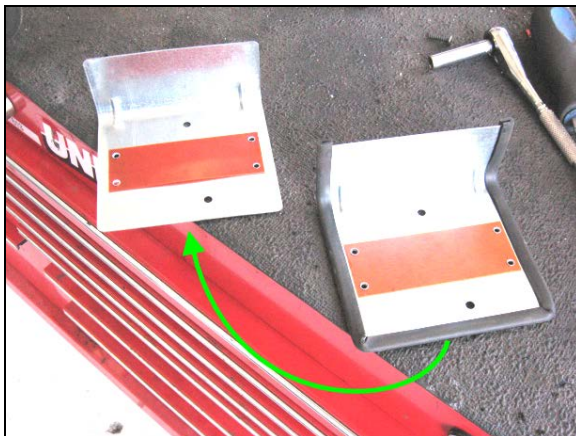
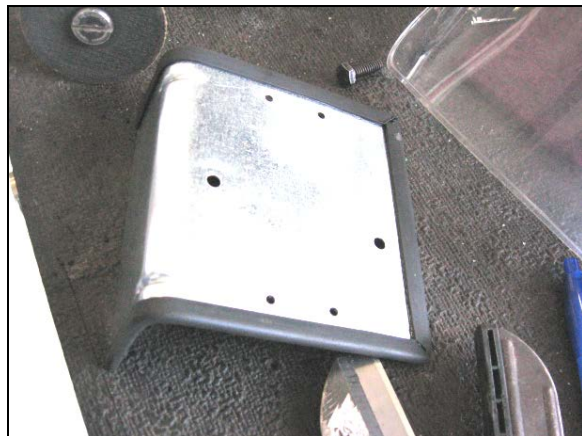
17. Remove the old relay cover trim, clean and put back on the new relay cover using fast drying adhesive (Loctite 404 or equivalent).

If the cover trim shows signs of deterioration or cannot be cleaned to allow correct adhesion, use 48cm (18in) of #56338 rubber trim to make a replacement.

The rubber trim is used on the relay cover to protect the surrounding wires and cable from abrasion against the cover sharp edges, Installation of the trim on the new cover is not an optional step.

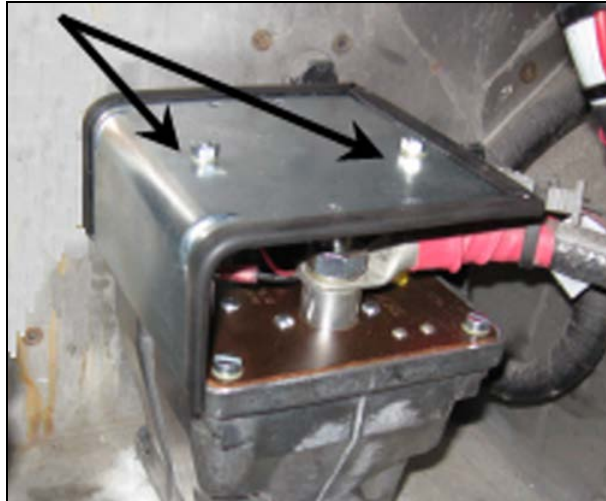
18. Using the two (2) hex nuts, install the cover on the relay.
