# Service Bulletin

**Subject:** Wind Whistle Noise At Highway Speed

**Models:** 2015 Chevrolet Tahoe, Suburban  
With Base Grille (without RPO Y91 or BPH)

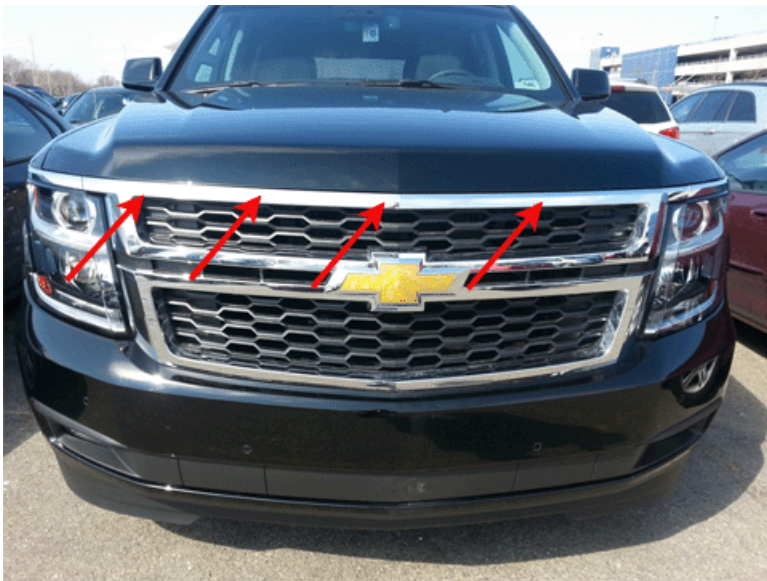
Some owners may comment of a wind whistle noise from the front end while driving at highway speeds. This concern may be more noticeable if there is a head wind or a strong cross wind. This concern could be caused by air whistling through the gap between the front compartment sight shield and the top of the grille, see below.

To root cause, tape the front of the hood to the top of the chrome on the Grille all the way from the left hand side to the right hand side. If the whistle is eliminated, install a foam strip (Kent Part Number P40125) in the recess between the chrome surround of the grille and the sight shield as shown below.
