Service Bulletin

Bulletin No.: PIC5964

Subject: Diagnostic Tip - Clarification Of Vehicles Equipped With Fog Light (RPO T3U)

Models: 2014 Buick LaCrosse

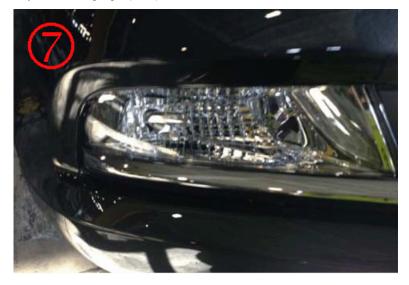
Fog Lamp (uplevel)

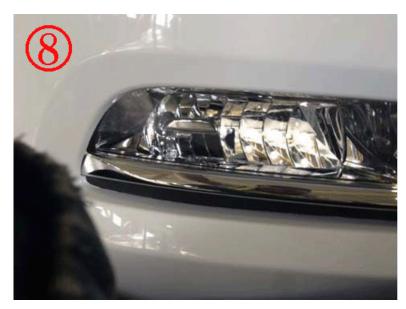
Fog Lamp Switch RPO T4F (HEADLAMPS-HIGH INTENSITY DISCHARGE and RPO T3U) is in the center of headlight switch.

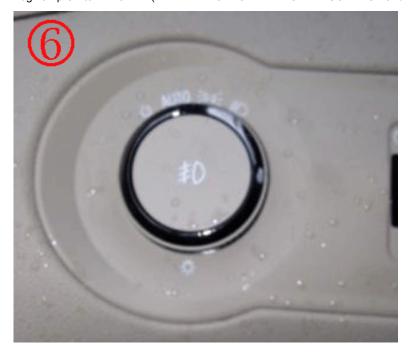
No Fog Lamp switch RPO T4A (HEADLAMPS-HALOGEN)
